Another New Toy

In another topic in this forum, I mentioned that I had to rearrange the shop for a Series 60/61 16 X 78 lathe. The lathe is a little short of 13' long and about 4' deep and weighs approx 9200 LBS. I looked at the lathe approx 2-3 months ago, before it was listed on ebay, and had to decide if I could live without it, but most importantly, where to put it. While I was making my decision, I called my rigger to see if he could lift it, and he also quoted me a price, which was extremely reasonable. By the time I made my decision, the seller had listed it on ebay, it didn't sell, and then it went into his stores category. I contacted him a couple of times, and apparently he an offer, but the buyer didn't pick it up. One of my friend's is the seller's former employer, we all keep in contact and communicate and he told me the seller's bottom line, which was a tad bit more than I was thinking, but not unreasonable, and definitely not any where near the ebay price. I paid the bottom line, apparently I'm not the thief the seller thought I was.

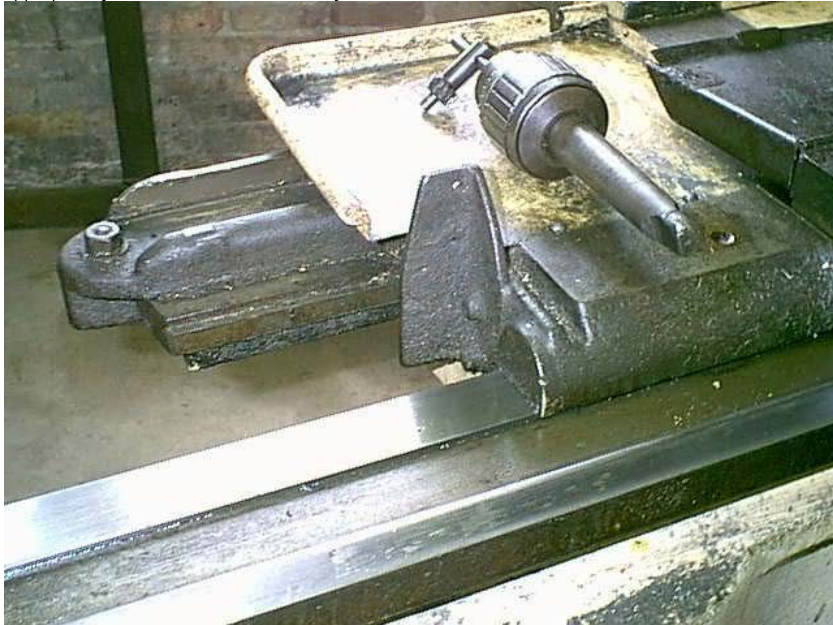
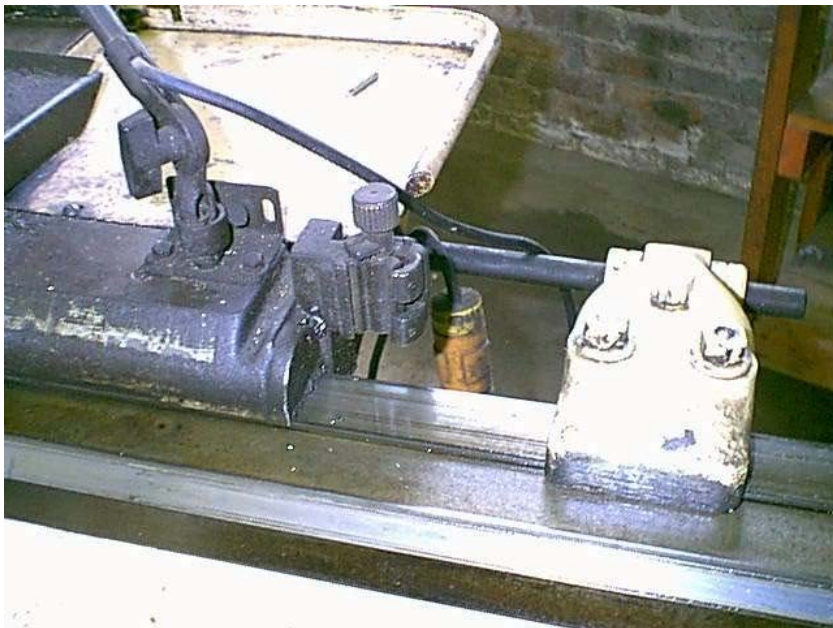
The bracket attached to the left rear saddle wing, I can only guess at its use. It's coming off, as is the bracket/adjuster attached to the right rear wing. In the second picture notice the TA bed bracket. First one I've seen that's not broken, and I do have the little rod, that is called appropriately "Bed Bracket Rod". I've always seen the little hole, but never the rod. Two firsts here.

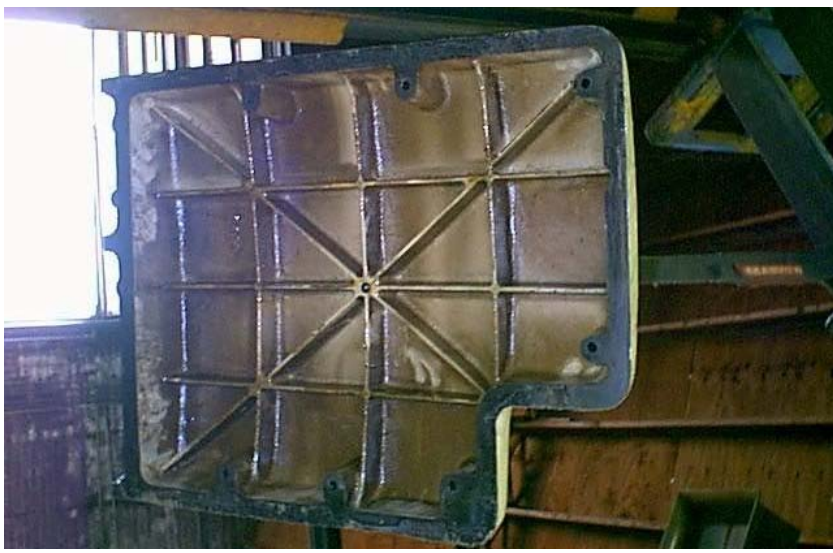
The section of the headstock cover you don't see. I was surprised by the amount of cross bracing cast into it. There is a 1/2-13 tapped hole at the X intersection for an eye bolt, which is how I lifted it off with my small forklift. The reason I took the cover off was to see where the oil level was, the sight glass on the rear of the headstock had been painted over. Although I cleaned it off, I couldn't tell if I was looking at oil or staining. The oil was/is over overfilled by about a gallon.

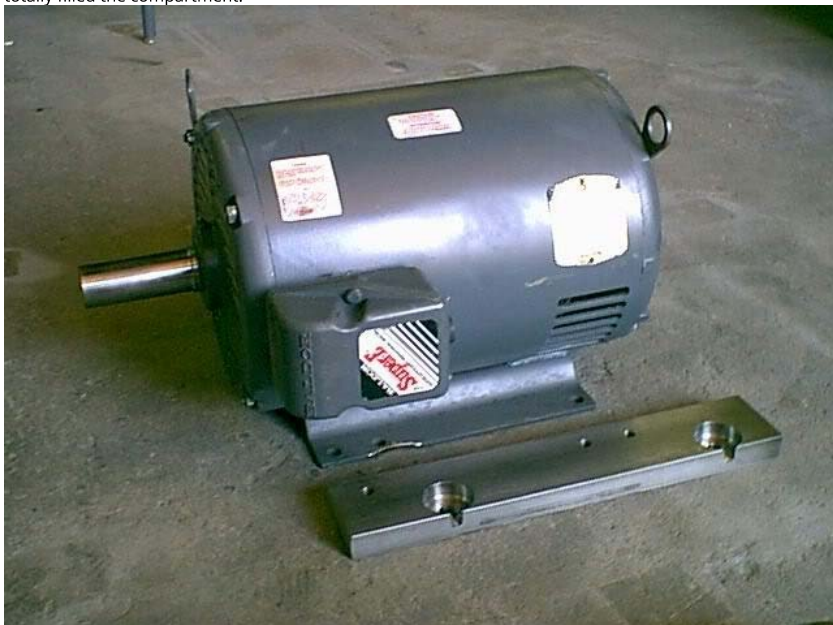
Well, the week started off with a call from the motor shop. To make a long story short, the motor that went to the shop is not the motor that came back. It seems the motor leads, with the cracked and missing insulation, went too deep into the windings for the shop to easily get to them without a complete rewind. The shop offered me some alternative motors, none of which seemed attractive after checking the frame and shaft sizes in the motor book, shaft diameter and length play a major part here. The original had a 1-5/8" D shaft 5-1/2" long. This necessiated a call to Monarch and I wound up talking to Scott. I explained the situation, and asked what was the largest horsepower motor I could put in the lathe. Scott explained that they normally put 10 HP in the machine, but if I could get a larger motor in there it would handle it. I'm thinking a 15 HP, because thats the size motor in the #5 J&L, and the lathe is being wired into that circuit. The motor book shows a 254T frame motor that comes pretty close to matching what I need without too much trouble or extra expense. Called the motor shop and 10 minutes later I had 15 HP 254T frame motor. All I needed to do was make some adaptor rails and install the motor.

The new motor and one of the adaptor rails. Notice the clearance cut out in the motor foot, it's there so I can get a socket wrench on the screw, after everything is in place. It's still pretty tight in the motor compartment. The second picture is the compartment, the original motor almost totally filled the compartment.

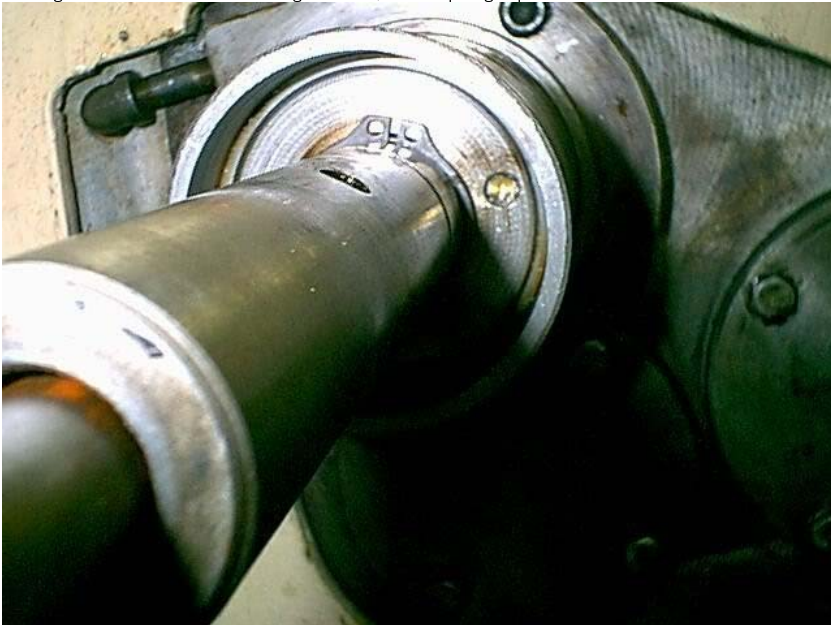
Bearing sleeve with the 88508 bearing removed, and snap ring in place.

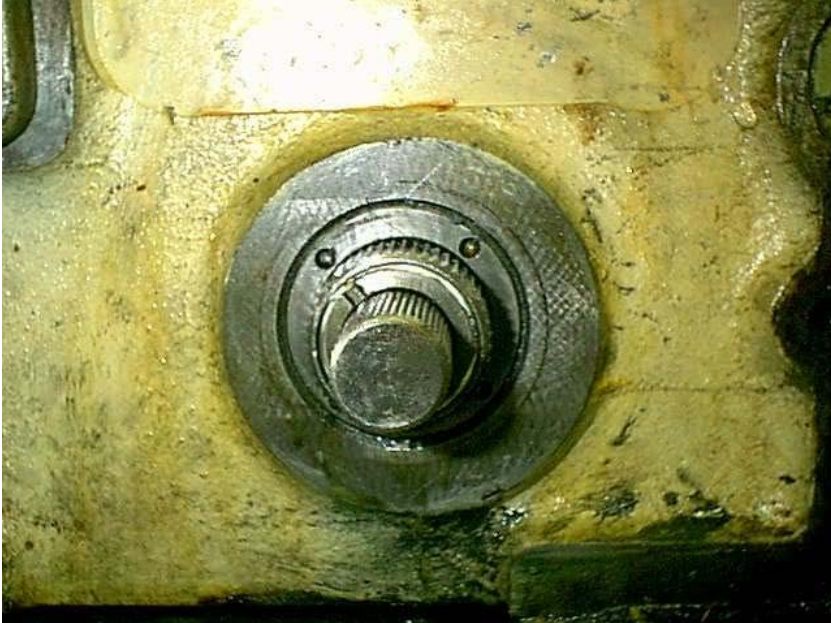
I've had the top cover off the gearbox for several days, and kept wiping oil off the right front area. Today the puddle was a little larger, and I decided to do some investigating. The speed shifting mechanism that you don't see is under the covers, and after looking at the manual I found that the covers just pulled off. The shifter shafts exit the headstock under the oil level, and sealed with gland nuts, and what looks like Oakem packing. Never could get the leaks to stop on my 16" CY or the 12" CK, but I significantly reduced the rate. I think John Oder knows exactly what I'm talking about here.

The majority of the problem, on this lathe, is that the gland nuts kept loosening every time the the speed was changed. The question is how to keep the nuts from loosening. I didn't care for the use of Loctite in this application, nor did I like the idea of upsetting part of the threads. The solution I arrived at was to wrap several layers of Teflon tape around the gland nuts in an attempt to increase the pitch diameter of the threads. It seems to have worked, for now.

The leaking gland nuts. There are 2 of them, the small one threads into the large splined shifter tube, and the larger one threads into the headstock. The Teflon tape has already been applied.

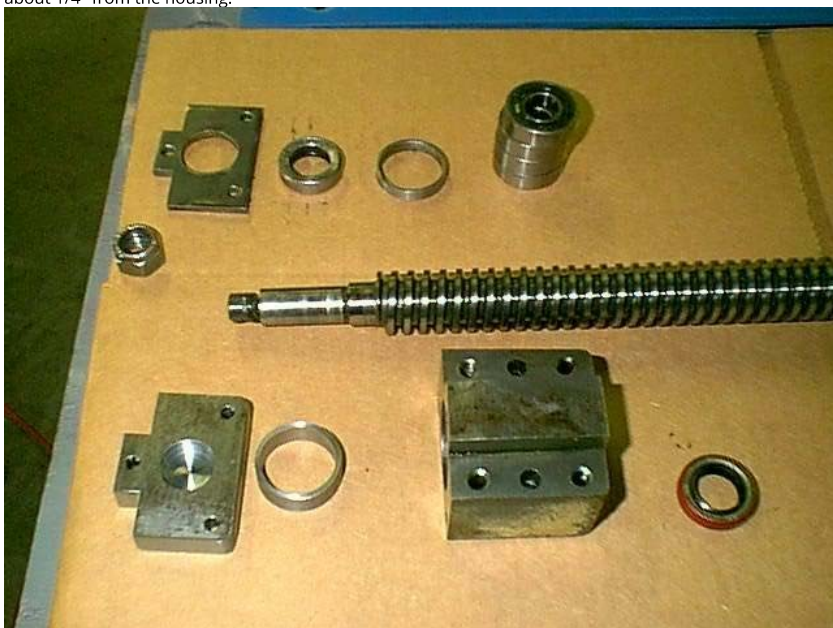
The fixed end of the cross feed screw. The top row of parts are in the order they came apart. The previous owners did a very "iffy" repair job. From L to R; The Nyloc nut, to the left below the retainer plate, has a set screw hole one of the faces. Very difficult to find and take apart. The retainer plate is a hack job, the seal was used as a spacer, and was ruined by the nut and should have been on the other end. The spacer as a result is about 3/16" too short, and the 4 sealed ball bearings should be angular contact bearings.
 The lower row: The new bearing retainer, new spacer, not shown are the 4 7202 angular contact bearings, they're still packed as I'm not to assemble yet. The bearing housing and a new seal.
 When I took this apart, the cross feed screw threads were flush with the end of the housing, definitely not the Monarch way, and should be about 1/4" from the housing.

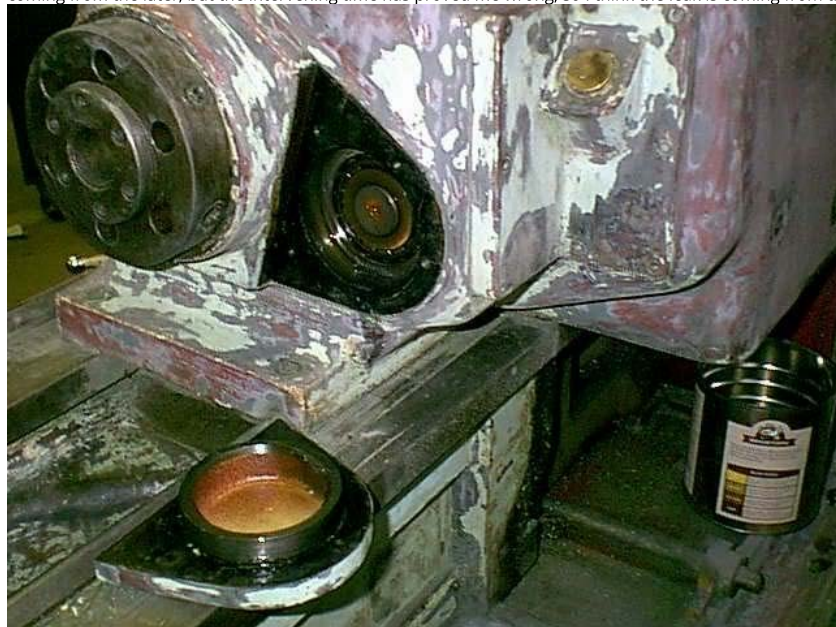
There was and still is an oil seepage problem around the spindle bearing cap and the front intermediate shaft cap. I thought the seepage was coming from the later, but the intervening time has proved me wrong, so I think the leak is coming from the spindle bearing cap.

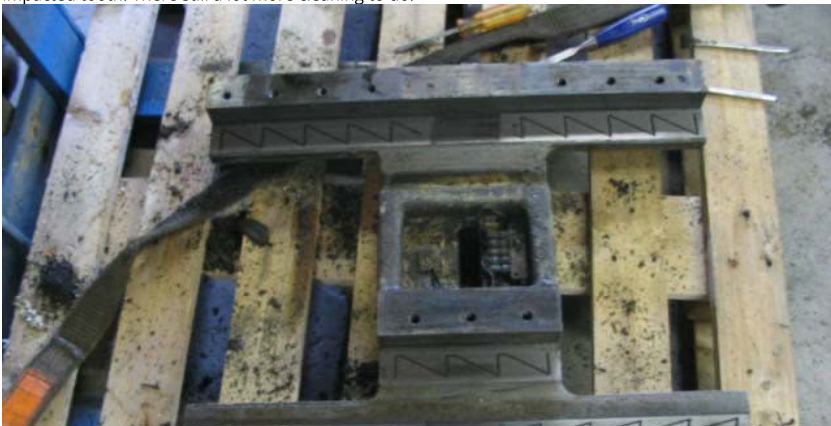
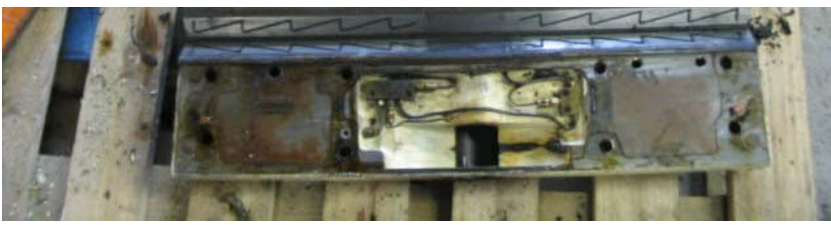
Overall view of the bottom of the carriage. There are 8 meter units that I've found, so far. 3 are in the apron section and 5 are in the bridge section. The bridge was almost a solid mass of grudge. I excavated most of the junk out, being about as delicate as a dentist excavating an impacted tooth. There still a lot more cleaning to do.

I'm not to encouraged by what I've found so far, I do believe there is more to do than I hoped for; maybe a little Multifil 426. I'll be running some checks over the next day or so.
Harry

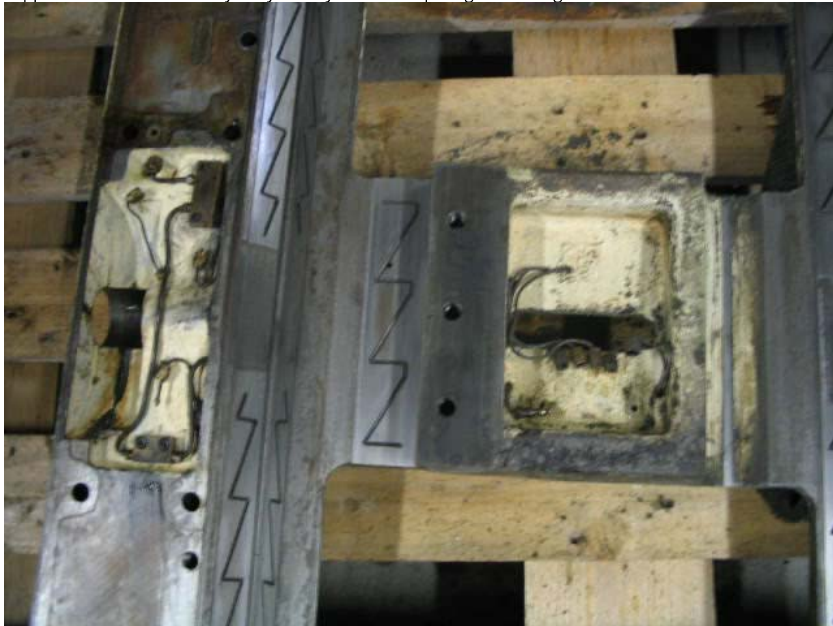
Bridge area of the carriage is a lot cleaner. Notice the oil hole in the inside flat slide. If I understand Monarch's design the inside flat slide is not supposed to bear on the way. Maybe they were anticipating the carriage wear.

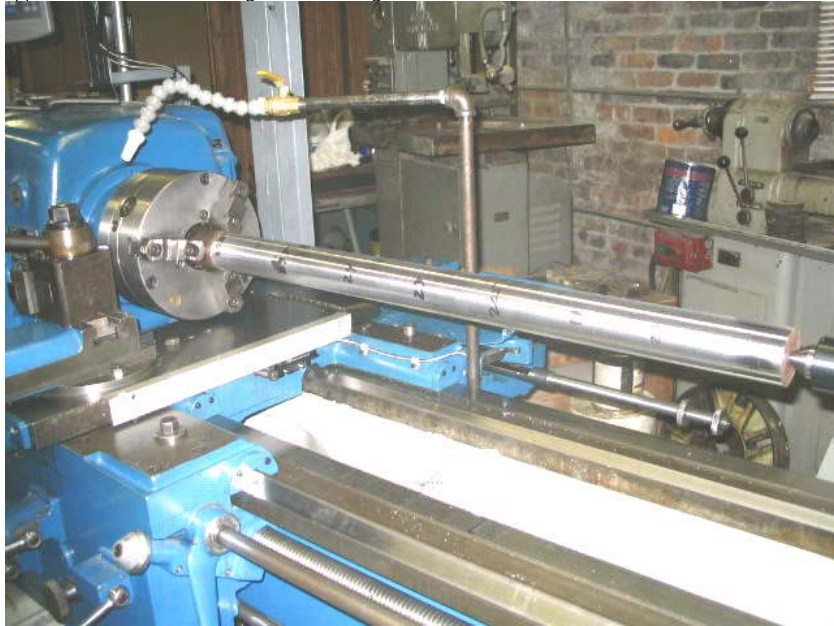
As you can see there a approx .005" bulge in the middle, and as you move to the left there is a slight taper, that will continue right into the chuck jaws. Unfortunately, this is where 95% of the work is done, if I want to make full use of the lathe. It's been said the mark of a good machinist is dealing with these problems. That's fine if you're the employee, but I'm the owner, and in my view that is not economical. I've got enough problems, and don't need to deal with these, if at all possible. When I'm working on a job, all I want to do is get it out the door as quickly as possible, and invoiced.

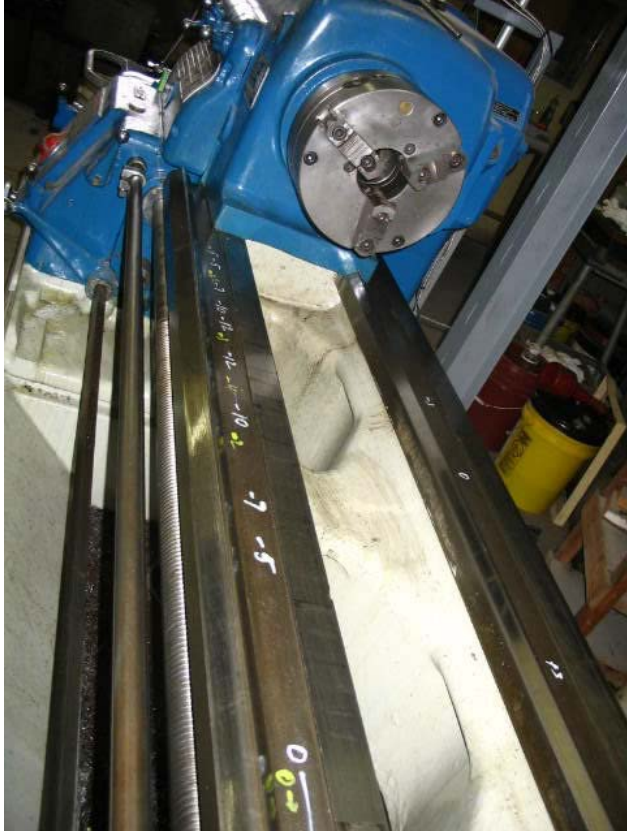
The white numbers are for the inside face, the yellow are for the outside face. I don't know how well they'll show up, but they are the indicator readings from the inside ways, of the wear on the outside way. They should be regarded with skepticism as they don't quite correspond with the test bar or the indicator from the carriage of the inside flat way. Never the less the wear is there, as evidenced by the test bar.

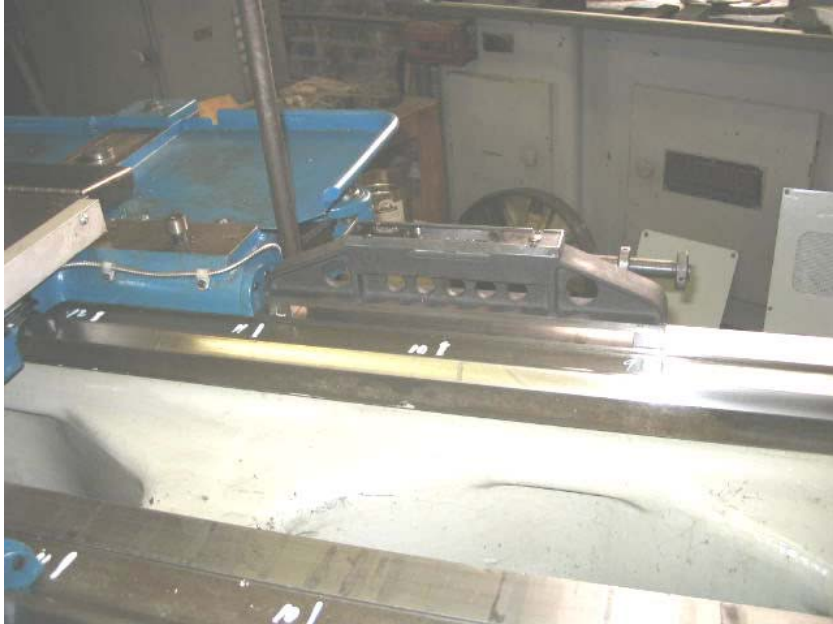
Checking the wear on the inside face of the outside V way. The outside face was checked in the same manner, as was the outside flat way. From position 0-8 the wear is 0, from 8-11 the wear is approx .007", from 11- 13-3/4 the wear is approx .002" going to 0.

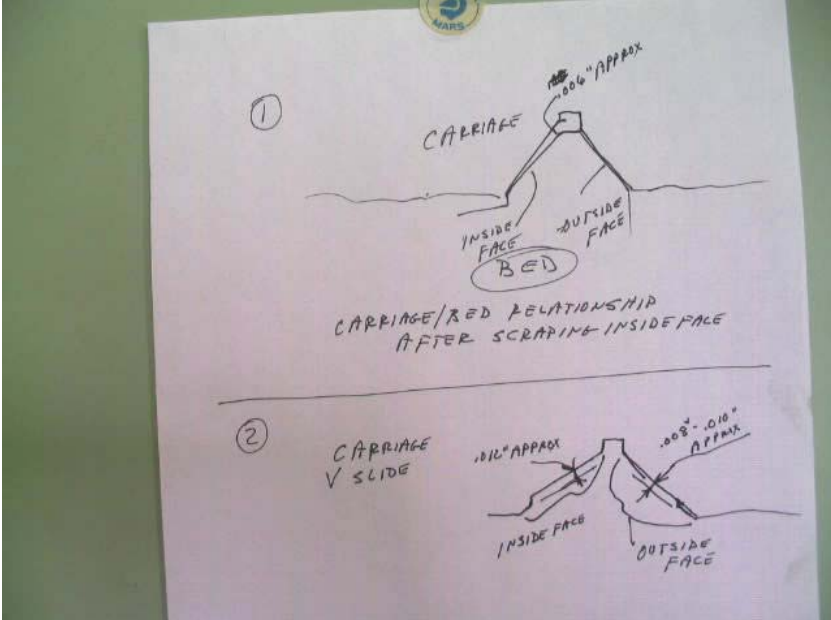
Sketch #1 is the carriage's V slide's relationship the V way of the bed after the inside was scraped. There is approx a .006" gap at the top of the inside face, which I think goes a long way to explaining the difficulty of moving the carriage.
Sketch #2 is the wear in the V slide, approx .012" on the inside face and approx .008-.010" on the outside face.
