Another New Toy

In another topic in this forum, I mentioned that I had to rearrange the shop for a Series 60/61 16 X 78 lathe. The lathe is a little short of 13' long and about 4' deep and weighs approx 9200 LBS. I looked at the lathe approx 2-3 months ago, before it was listed on ebay, and had to decide if I could live without it, but most importantly, where to put it. While I was making my decision, I called my rigger to see if he could lift it, and he also quoted me a price, which was extremely reasonable. By the time I made my decision, the seller had listed it on ebay, it didn't sell, and then it went into his stores category. I contacted him a couple of times, and apparently he an offer, but the buyer didn't pick it up. One of my friend's is the seller's former employer, we all keep in contact and communicate and he told me the seller's bottom line, which was a tad bit more than I was thinking, but not unreasonable, and definitely not any where near the ebay price. I paid the bottom line, apparently I'm not the thief the seller thought I was.

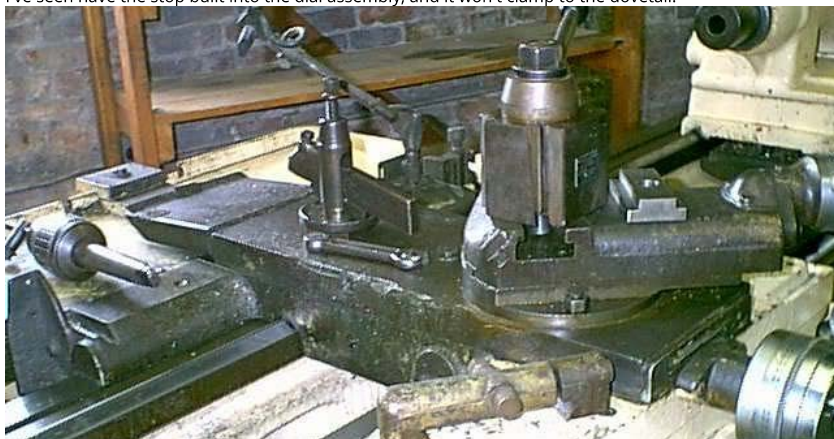
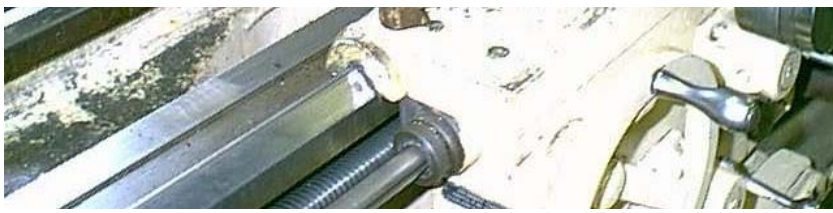
I've taken some more pictures today. The cross slide on the this lathe is just an 1" or 2 shorter than the ways, compared to the CY's which is several inches shorter, (think a feature of "Super Lathe"). The cross slide and compound have had a run in or two with the chuck. The T nut for the Dorian toolpost needs a bit bit of fitting, it was too small for the CY. I don't what lathe the South Bend style cross slide stop fits, or why it's with this machine, all the Monarchs I've seen have the stop built into the dial assembly, and it won't clamp to the dovetail.

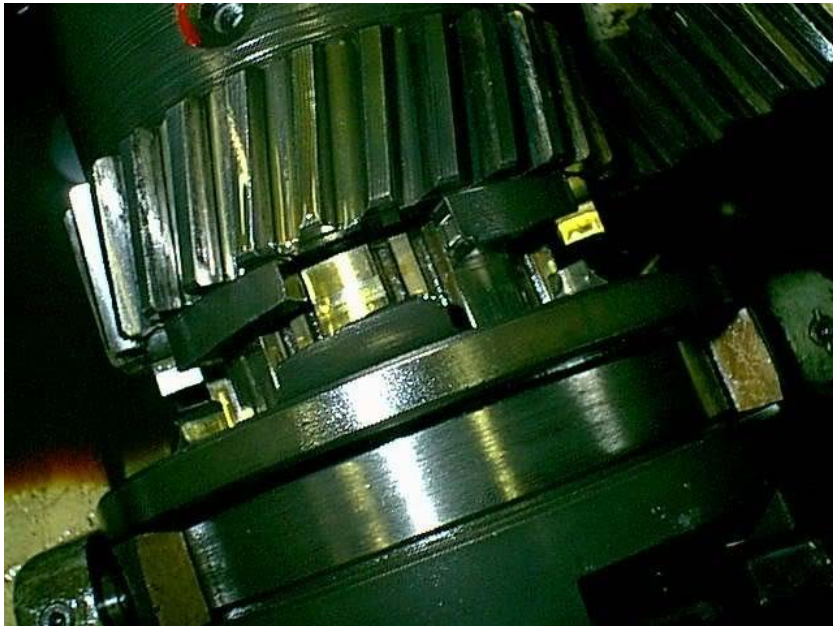
This is the clutch between the bull gear and the "Large and small spindle drive gear", with small one showing in the picture. It's hard to see but the corners of the clutch teeth are a bit chewed, probably from inadvertent shifts on the fly. I know I try avoid this, but every now and then it happens. The only potential problem I see here, is that this gear is used in the 8 highest speeds, and the load carrying capability may be affected.

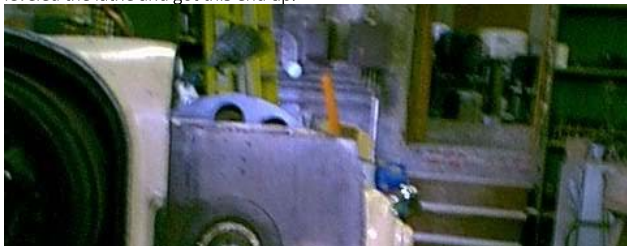
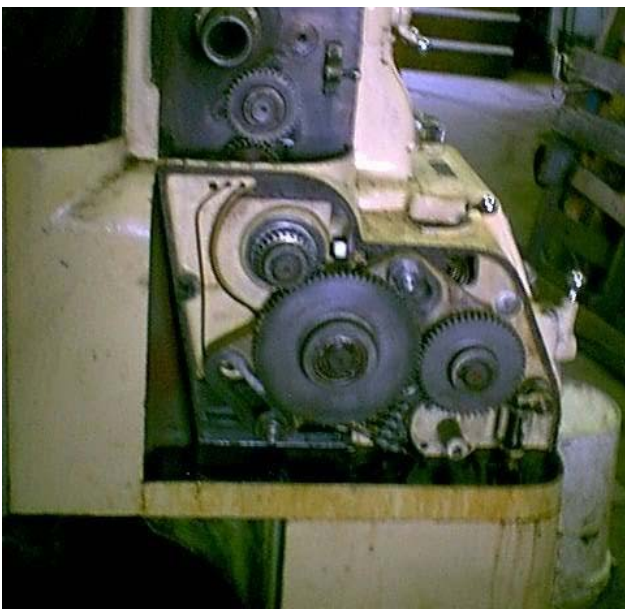
The end gears. The gearbox has its own pump, and the sump is filled to overflowing, which explains the oil spot on the floor, before I rough leveled the lathe and got this end up.

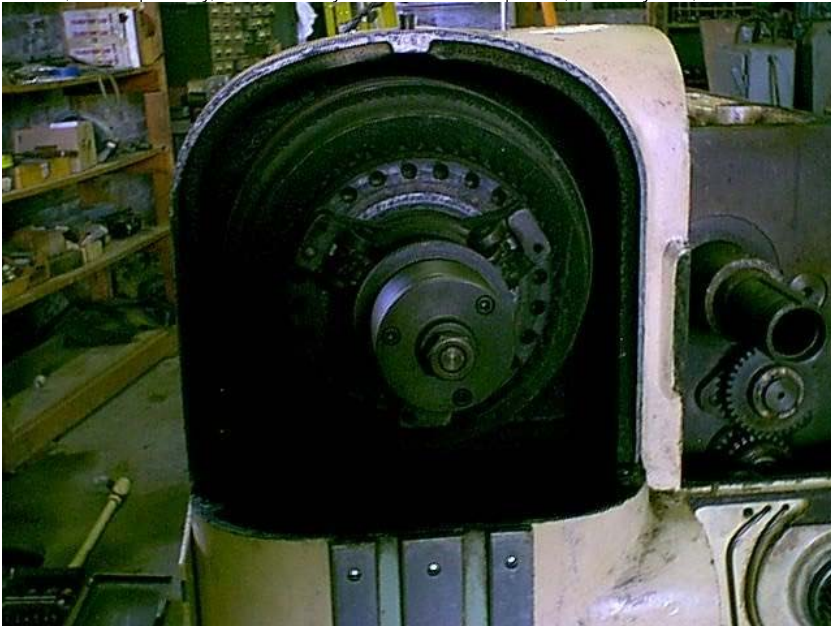
One more picture.
The spindle drive sheave and clutch. If you can't see details, that's for 2 reasons; one my camera isn't the best nor am I the best photographer, and two, most importantly, that's how dirty it is. The insides are painted, I believe yellow, and that should show up.

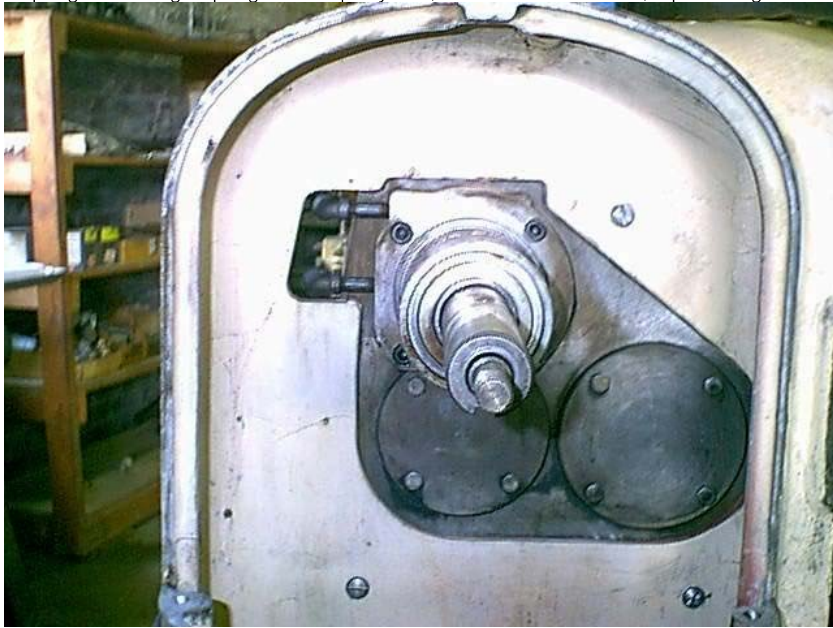
What the parts sheet doesn't show are the 2 pipes on the left, of the "Bearing sleeve" and the 4 screws attaching the sleeve to the headstock. The lower pipe has a grease fitting, and the upper pipe has a relief valve. The sheave assembly slides over the sleeve and is held in place with a snap ring. The missing snap ring holds the pulley shaft, in the center of the sleeve, in place and goes next the bearing inside the sleeve.

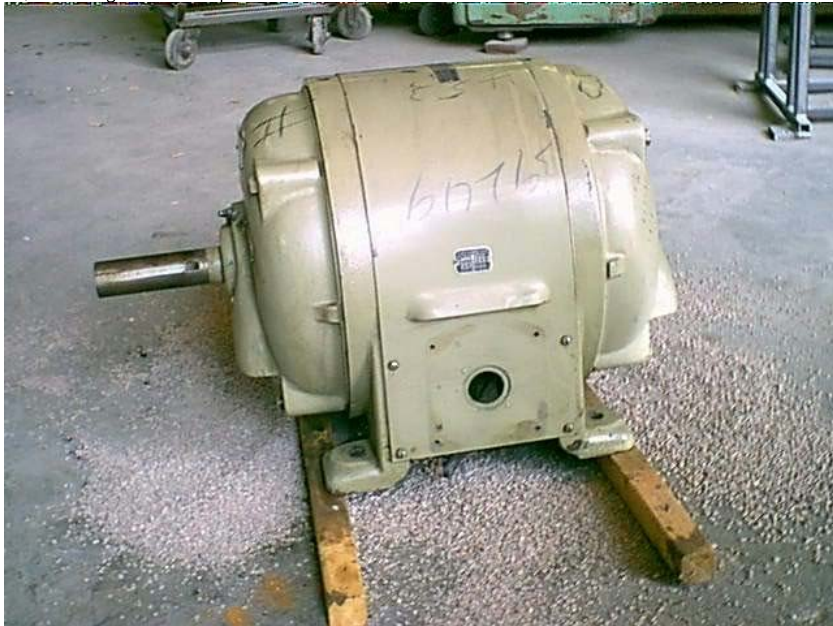
The motor did have a peckerhead, you can tell by the shadow of the outline, but it had to be removed. There is no way the motor would go into the compartment with it mounted. The wire connections are made underneath the middle cover. The cover is held on by 4 screws on each side, and I made the mistake of taking it off. The 5 digit number that you see is the lathe's serial number,; whether Monarch put the number on, or the original owner replaced the motor, I couldn't tell.

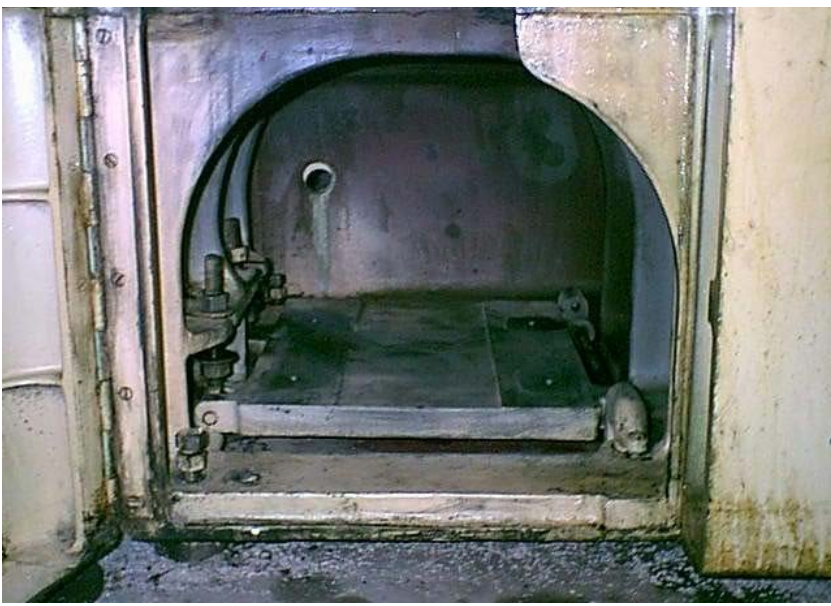
The new motor and one of the adaptor rails. Notice the clearance cut out in the motor foot, it's there so I can get a socket wrench on the screw, after everything is in place. It's still pretty tight in the motor compartment. The second picture is the compartment, the original motor almost totally filled the compartment.

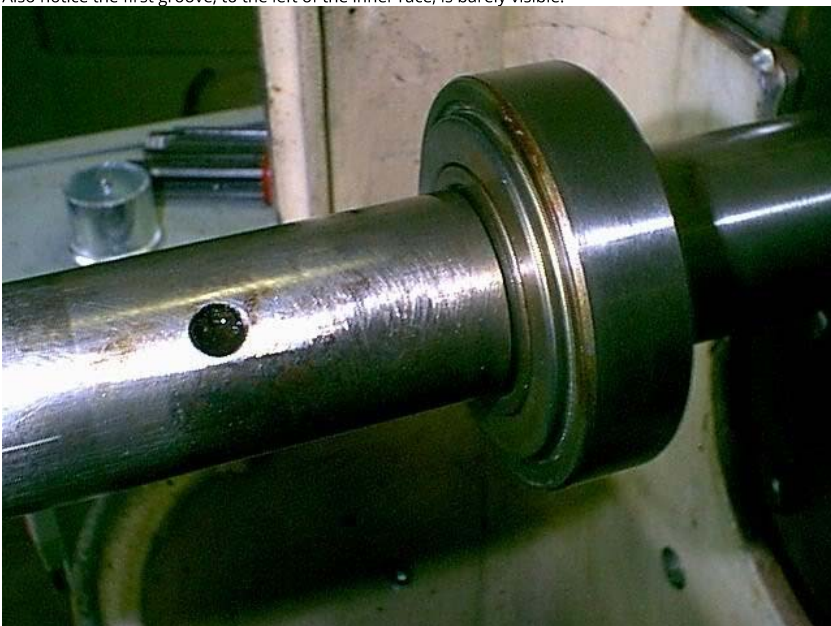
88508 bearing against the snap ring as it's supposed to be. Keep the hole to the left in mind, it's going to present a problem and questions. Also notice the first groove, to the left of the inner race, is barely visible.

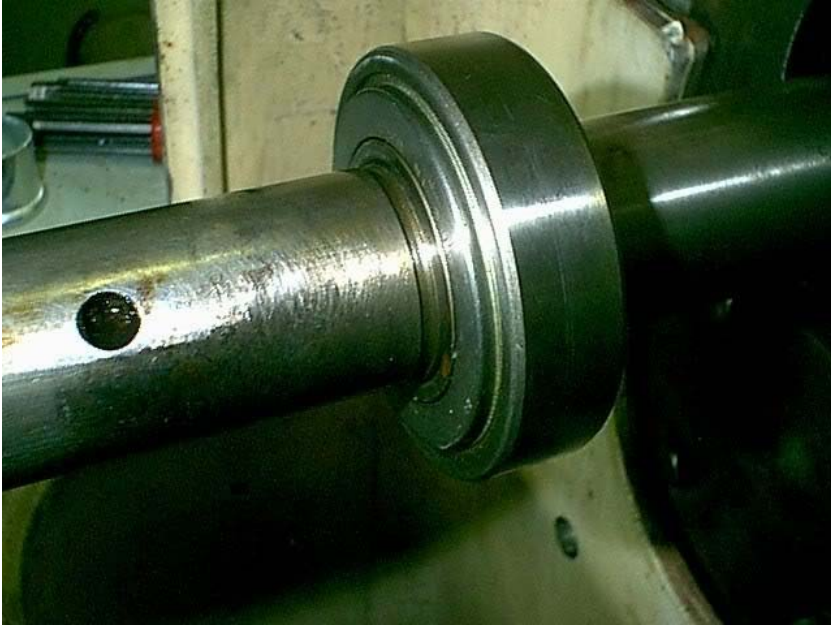
This is how the groove appears without the snap ring, but the bearing in place, pushed against the shoulder formed by the larger diameter to the right. Notice that the groove is wider, by about .073".

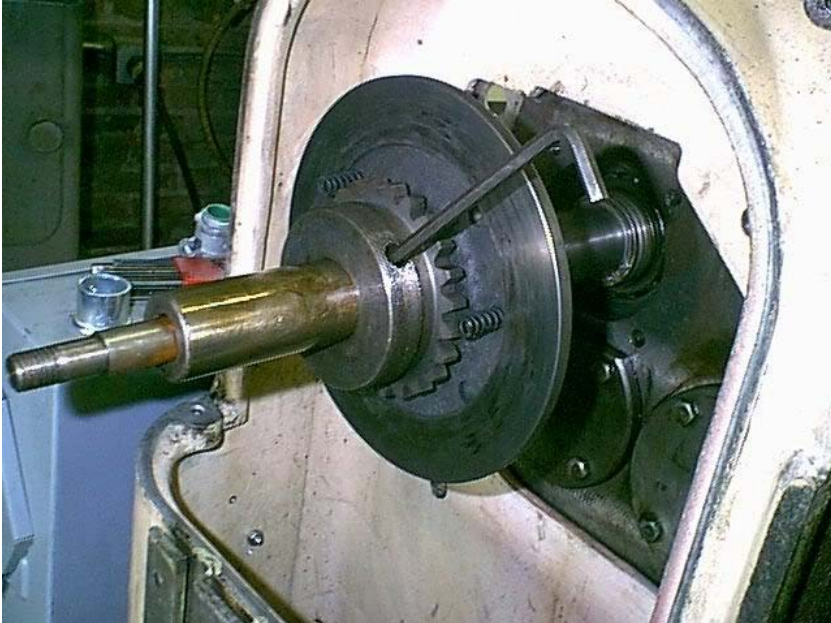
The "clutch hub and backplate" in place. The Allen wrench is in the set screw, which is firmly seated in the hole in the shaft, as it's supposed to be; but, and this is very important, the snap ring had to be removed in order to seat the set screw. With the snap ring in place, the hub was .073" further to the left, and the set screw wouldn't seat. This presents a question; is the 88508 bearing the right bearing? 88xxx bearings have the inner race extended on both sides, on the 88508 it 3MM (.1181") per side. Switch to an 87xxx bearing, the inner race is extended on one side only. If an 87508 bearing is used there is a gap of approx. .045", that may have to be accounted for. It looks like another call is needed.

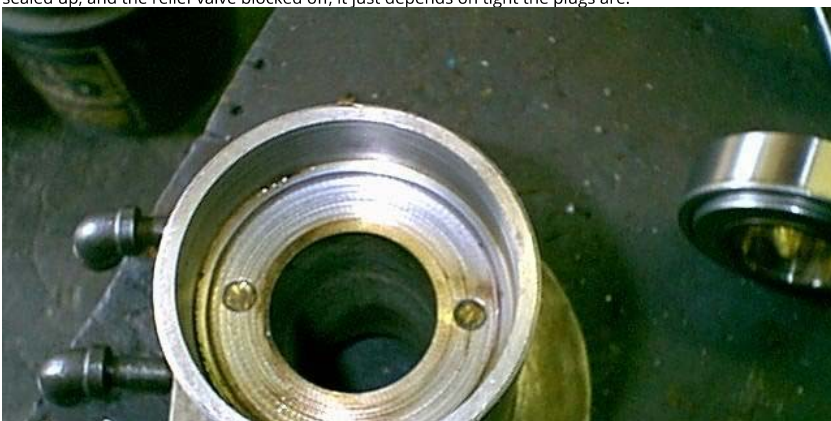
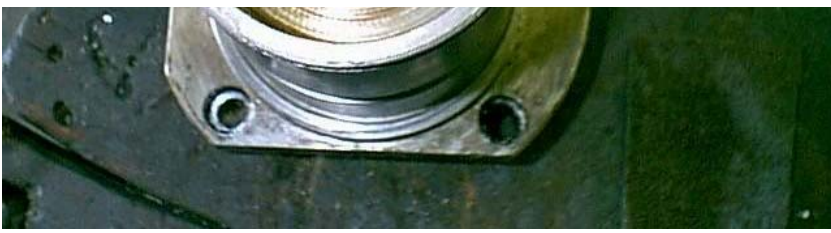
The bearing sleeve with the 88508 bearing removed. Notice the brass plugs on each side of the hole. These plugs are sealing the holes drilled into the casting that connect to the lubrication pipes on the left. The grease comes in the lower pipe, circulates around a groove on the OD of the sleeve and exits through the relief valve in the upper pipe. I think the 88508 bearing is removed by hydraulic pressure if the OD groove is sealed up, and the relief valve blocked off, it just depends on tight the plugs are.

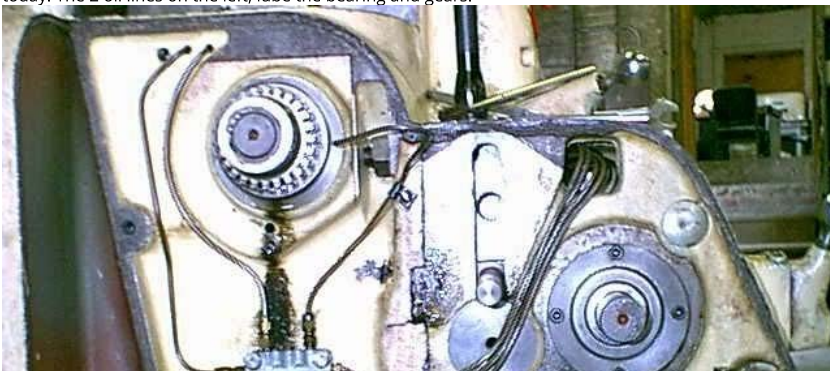
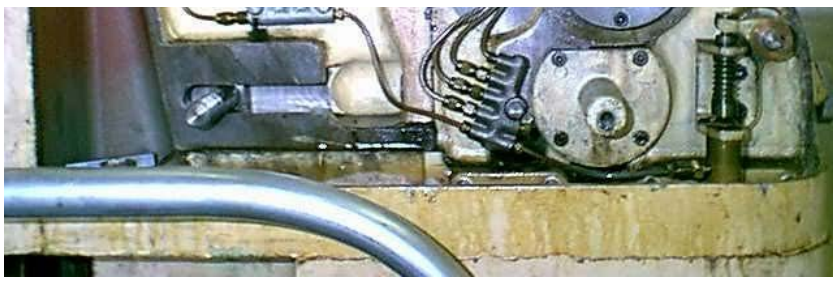
The end gearing has been removed to more effectively expose the oiling system. There are 2 manifolds feeding a total of 7 meter units for the gearbox. 6 of the meter units are visible, and I'll show the 7th in the next photo. Notice the black oil slick under the spindle stud gear. There are 2 other gears on the other side of the casting, which forms a bowl next to the headstock. I couldn't find the drain hole last week, but I found it today. The 2 oil lines on the left, lube the bearing and gears.

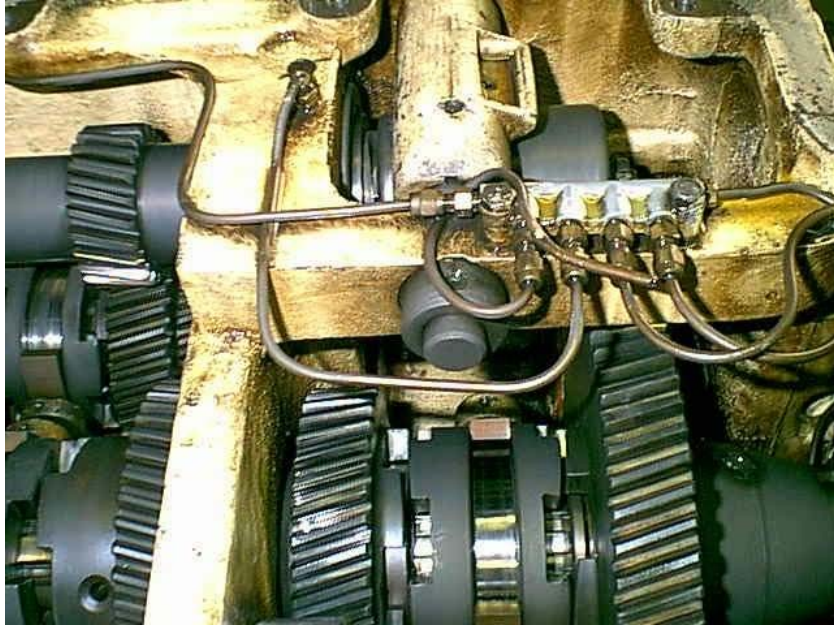
The meter unit manifold in the headstock. The front tube on the left needs to be redirected towards the rear between the clutch yoke and the casting for oiling the brake fingers. BTW, the brake works great.

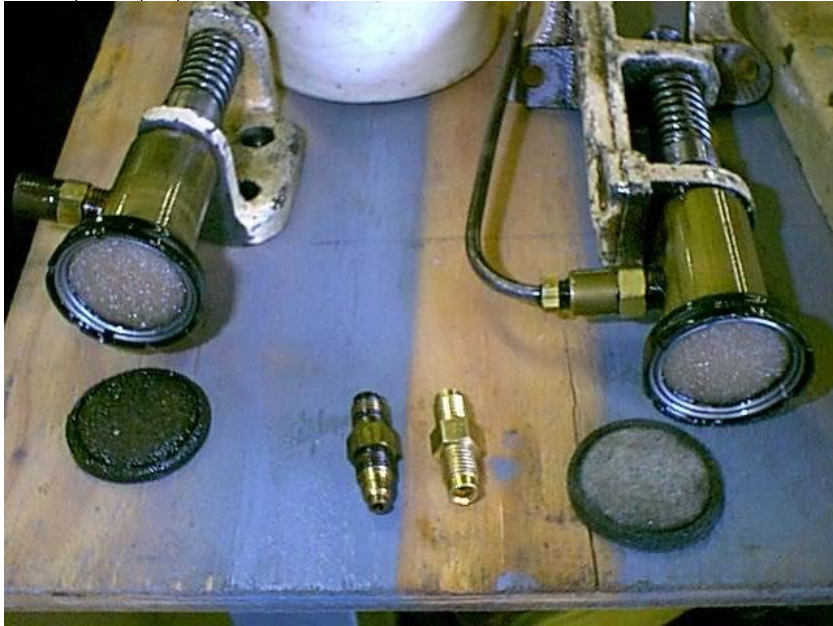
A close up of the pumps and meter units.

The Bijur meter unit has a radiused end on the inout, that I think acts as the compression seal, the "Trico's" don't and I think that may be the cause of the leakage problem. I think an easier solution to that leakage problem would be to put some pipe dope on the threads.

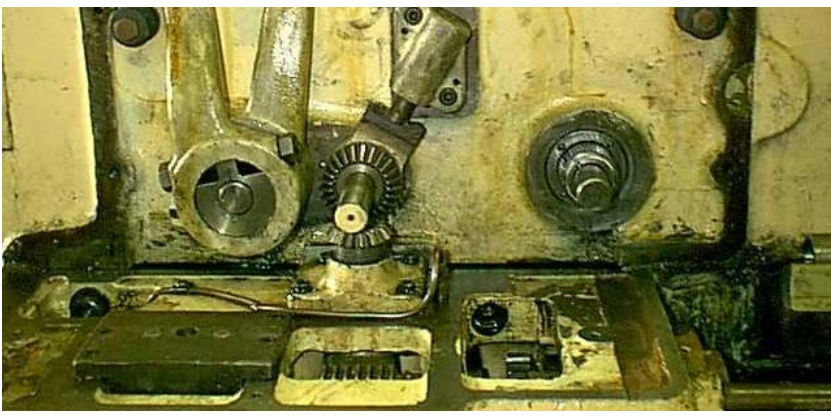
Covers removed, and right side tube levers(shifters) removed. The bevel gear set, in the middle, is part of the leadscrew reverse mechanism. The 6 bumpers, I couldn't find them in the parts manual, apparently limit the travels of the tube levers.

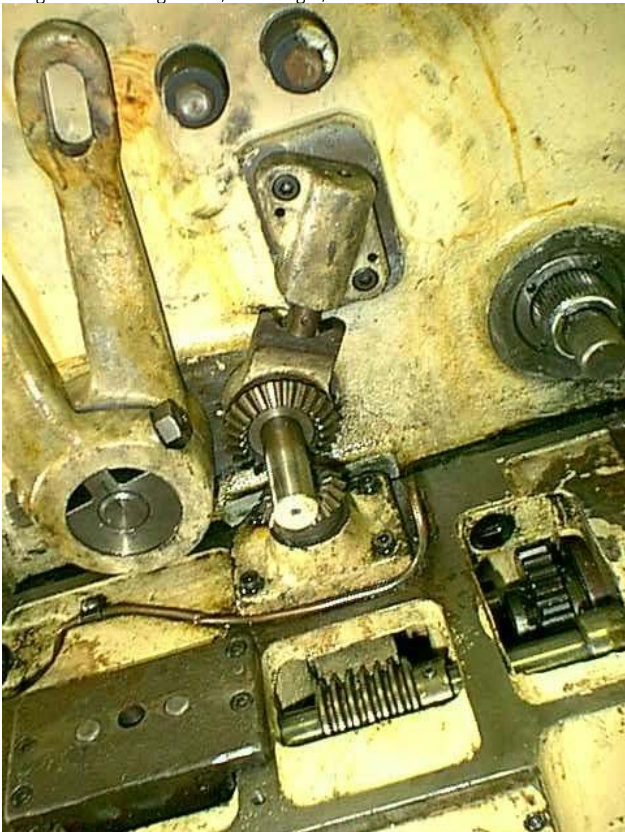
A better view of the leadscrew reverse mechanism, and for those of you who aren't familiar with this, I'm going to attempt to explain this. The large bevel gear is pinned to the shaft, which goes inside the headstock, and is pinned to the single dog clutch shifter yoke. Also pinned to this shaft is a three position detent, which is above the bevel gear. The small bevel gear is attached to the gear segment inside the gearbox, which meshes with the circular gear rack, which is pinned to the reverse rod, that runs the full length of the bed. The motion, left and right, of the rod, comes from the worm which inside the nut casting to the left. The rod's motion is imparted by the lever mounted on the apron; up, neutral, and down, which gives the feed direction.

The gear inside the gearbox, on the right, is attached to the leadscrew.

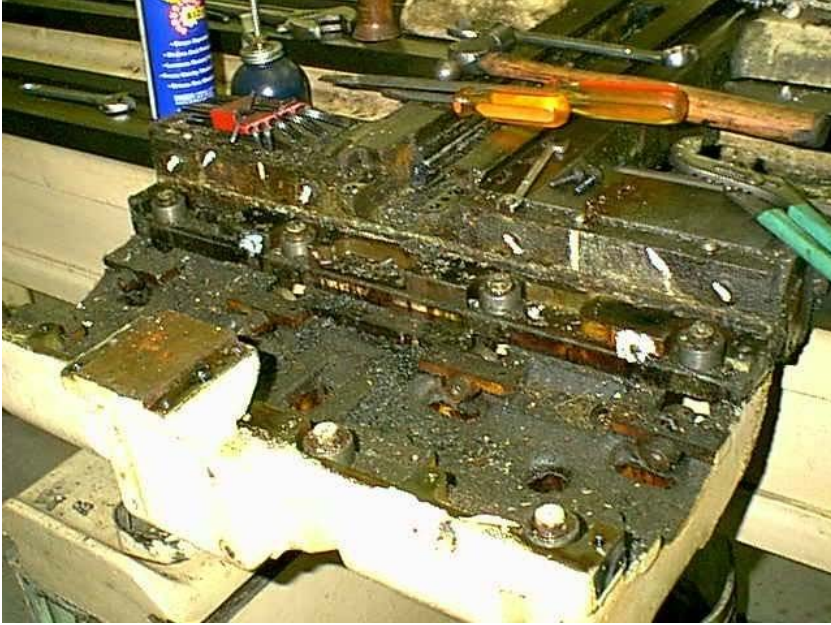
There are 6 screws and 2 dowel pins attaching the TA's carriage bracket to the carriage, the 2 dowel pins and 4 of the screws are plainly visible with the TA assembled, but there are 2 screws that are buried, requiring the above disassembly. The screws and dowel pins are marked in white. There are 2 errant marks, they are the 3rd from each end on the top row.

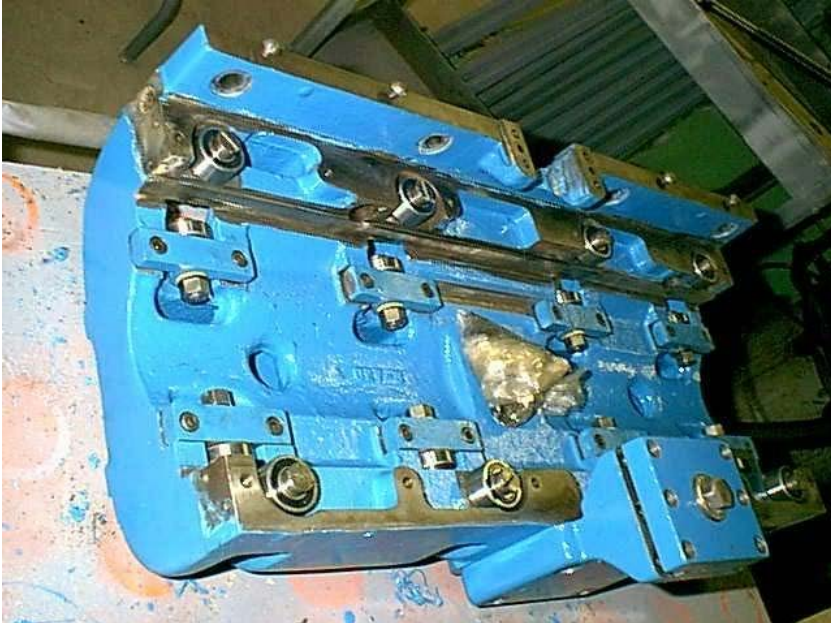
TA carriage bracket ready for reinstallation, but that's aways off. The carriage and apron have to come first. The little bag in the middle contains misc parts. The horizontal double row ball bearings form the vertical ways for the slide, and the vertical single row bearings form the horizontal ways. Each bearing is adjusted by an eccentric stud, with approx .025" offset(I had to make one).

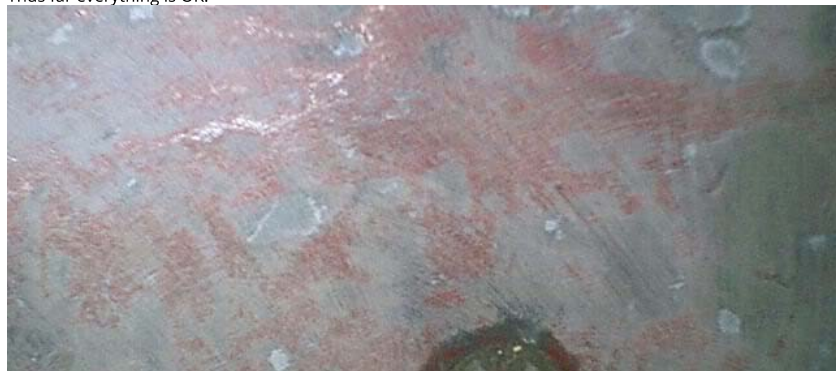
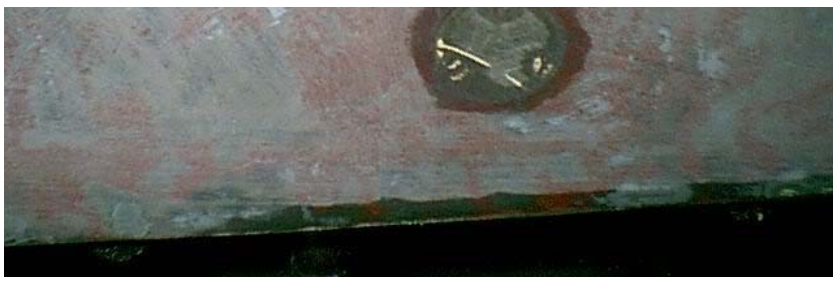
Another oil seepage spot on the rear of the headstock. I removed the cover, cleaned the surfaces and applied Loctite 515 Gasket Eliminator. Thus far everything is OK.

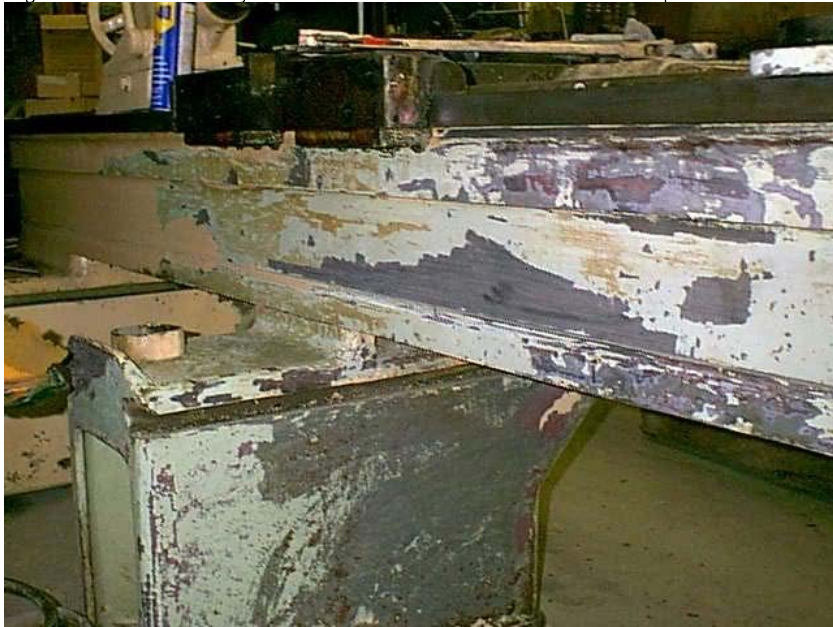
The rear of the bed where I've been scraping the old nasty "yellow" paint off, Comes off rather easily, there wasn't much prep work done by the original owners. One curiosity I noticed is that the most of the bed sheer has been planed.

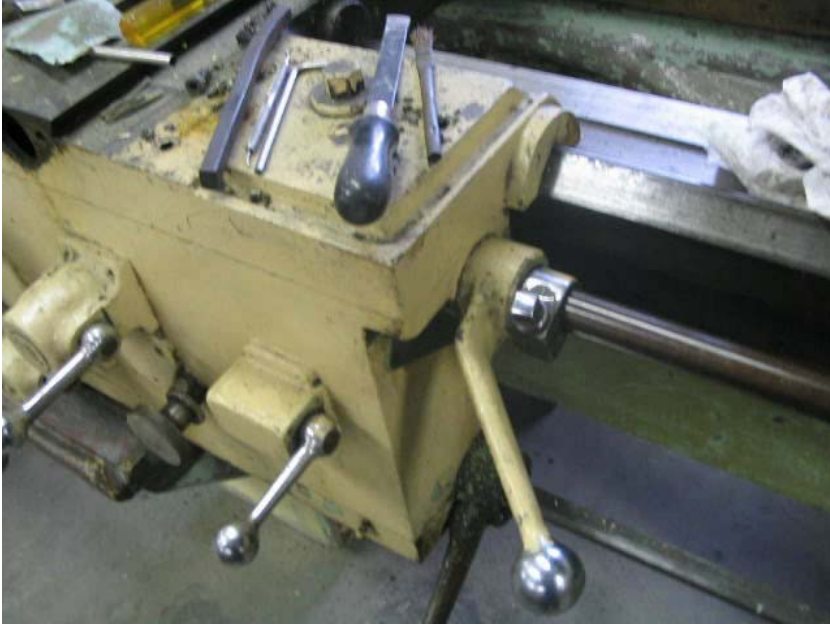
The feed stop on the reverse shaft locked in place hard against the carriage, and used the carriage to do the extraction, very easy. The scarring on the shaft can be filed off, but I'll always have a reminder.

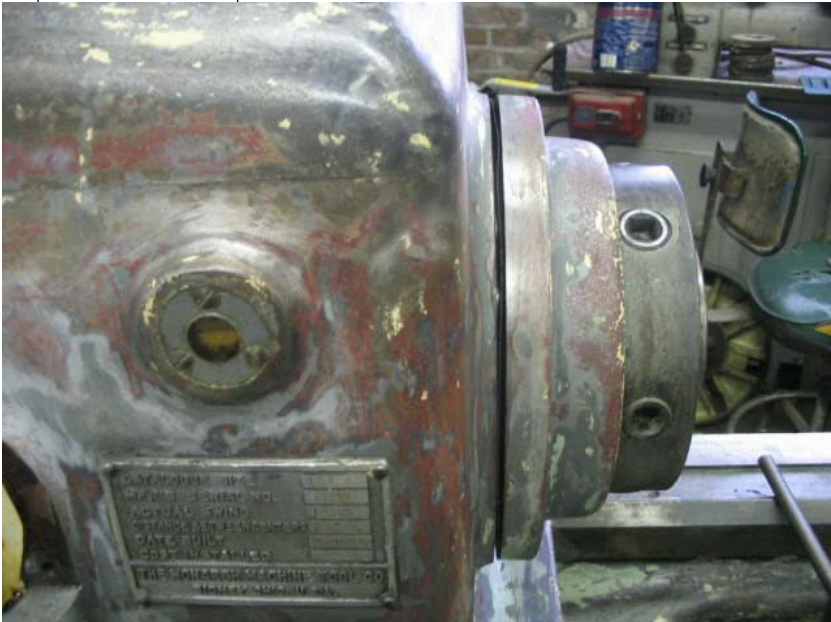
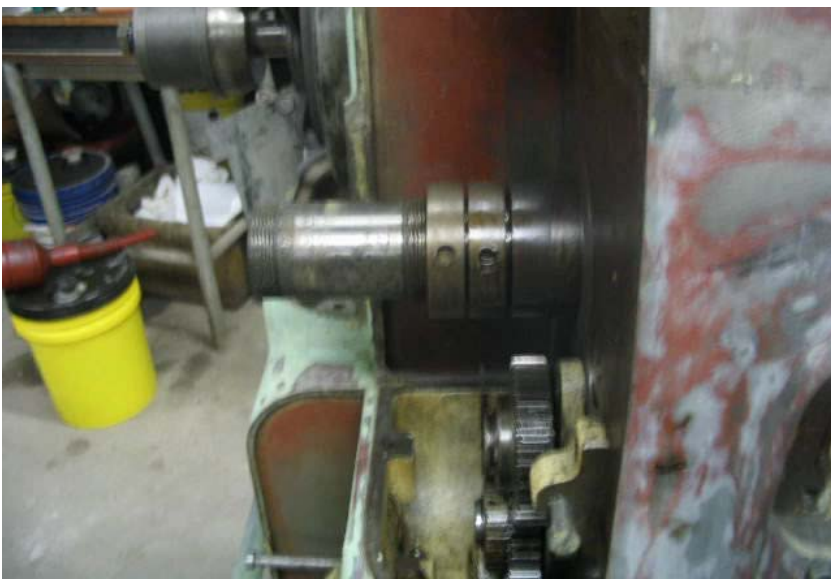
In my post of 1-27, I mentioned that the spindle bearing cap was leaking, actually it was a seepage problem, a very small one, but aggravating. I'm also in the process of painting, more like slopping paint on, the lathe, and I want to get this seepage problem corrected. The seepage was not coming from the spindle, but from the lower side or bottom of the cap, next to the front intermediate cap(see the picture in 1-27's post). Removing the cap is not as easy as it seems, it's just like the cap on the EE, there's a flange behind the D1-6 end which means that the spindle has to come out. If I had to do that, I would have lived with the seepage, I'm not pulling a spindle unless I absolutely have to.

I came up with the "what if" question: If I removed the 5 screws attaching the cap to the headstock, how much could I move the cap forward in order to get in there and clean the surfaces and apply some sealant and reattach. The net result of this long story is that I called Monarch and spoke to Scott about this issue. Scott suggested that I loosen the bearing preload nuts on the back end of the spindle and move it towards the tailstock. The only problem is that he didn't know how much clearance I would gain, with the bull gear being the biggest problem. I thought of one other potential problem concerning the clutches and how much movement they would allow. There was only one way to find out.

I think the original owners had the spindle out; the spindle bearing cap screws holes were loaded with Permatex, as were the screws. I don't think Monarch used Permatex, at least I've never seen it when I'm the first one to remove a screw.

I proceeded to loosen the nuts, and remove the screws, I and then I got out the soft face hammer. That didn't work, so I got I my gentle persuader, and an aluminum block, and a few whacks later the spindle was moved about 3/16". I would have liked a bit more room, but I wasn't going to tempt the fates.

The next issue was cleaning the mating surfaces, and there are 4 of them; both sides of the gasket, and the iron faces of the headstock and the bearing cap. I tried a bit carburetor cleaner followed by acetone, and finally blew it out with canned air, the type that is used to clean keyboards. I wanted something gentle and not a blast from an air compressor, which I figured would do some damage to the gasket and not telling what else. The next issue was applying the sealant. I rotated the cap 360*, the intermediate has to be removed to rotate the spindle bearing cap, applying the sealant to the bearing cap side of the gasket, pressed it against the cap, and repeated for the headstock surface. This sealant I chose for this application is Loctite 515 Gasket Eliminator.

I next coated the cap screws, under the heads, with RTV. I then drove the screws in and tightened the preload nuts and refilled the headstock with oil. So far, it's been about 6 hours, there are no leaks. I'll see how I did tomorrow, and if no leaks, I'll be slopping some more paint.

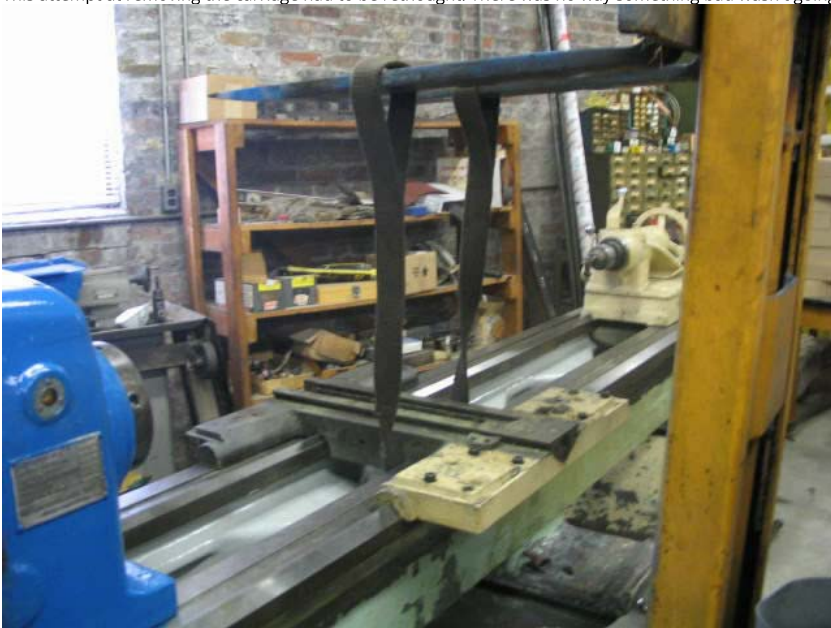
This attempt at removing the carriage had to be rethought. There was no way something bad wasn't going to happen.

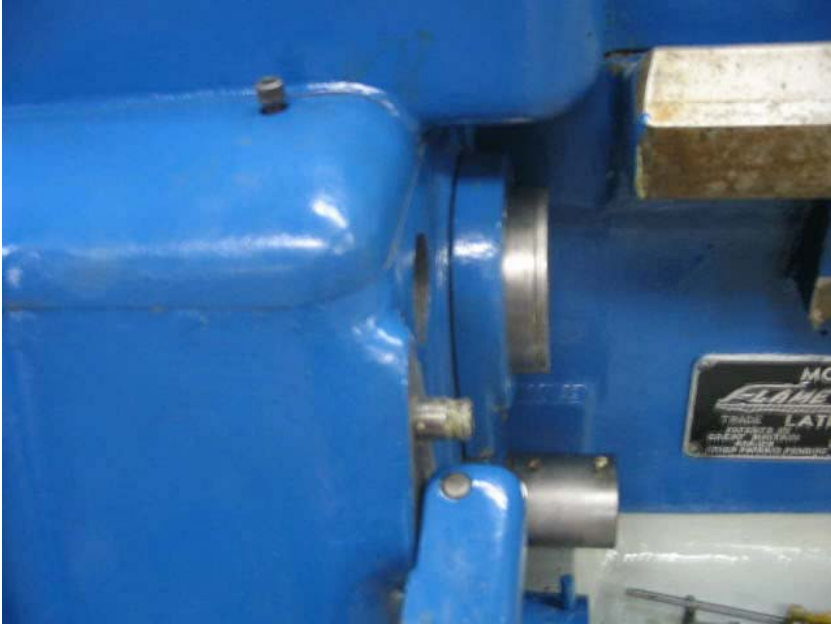
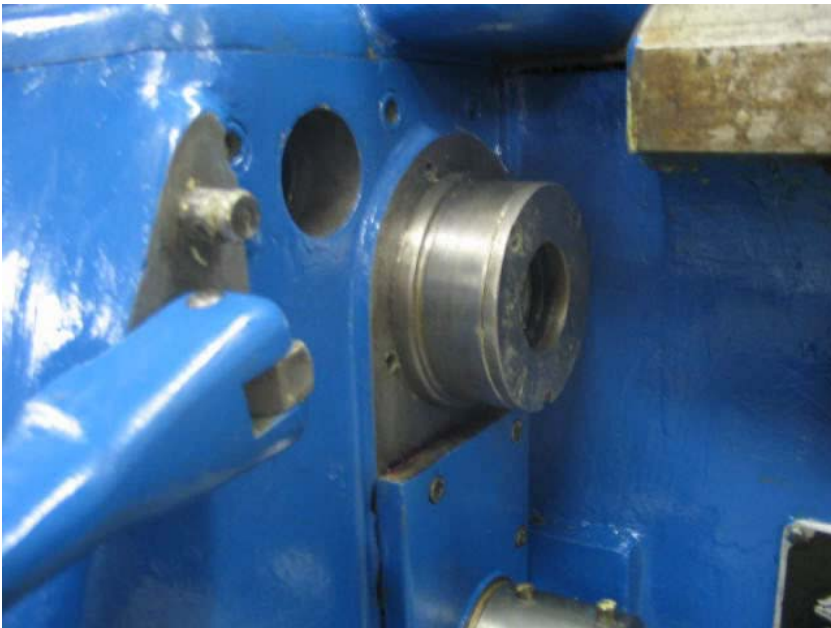
There is a bearing cartridge for the leadscrew that goes into the gearbox and is retained by a cap. There was so much paint and dirt in this area when I took it apart that I never saw the gap between the cap and the gearbox, but I saw it today. Checked the manual and there is supposed to be "Linear O ring" between the gearbox and the cap. The question of the day is this a special type of O ring, or just a 50 year old name for an O ring? The gap is about .050", and the ID of the O ring would be about 3-7/16".

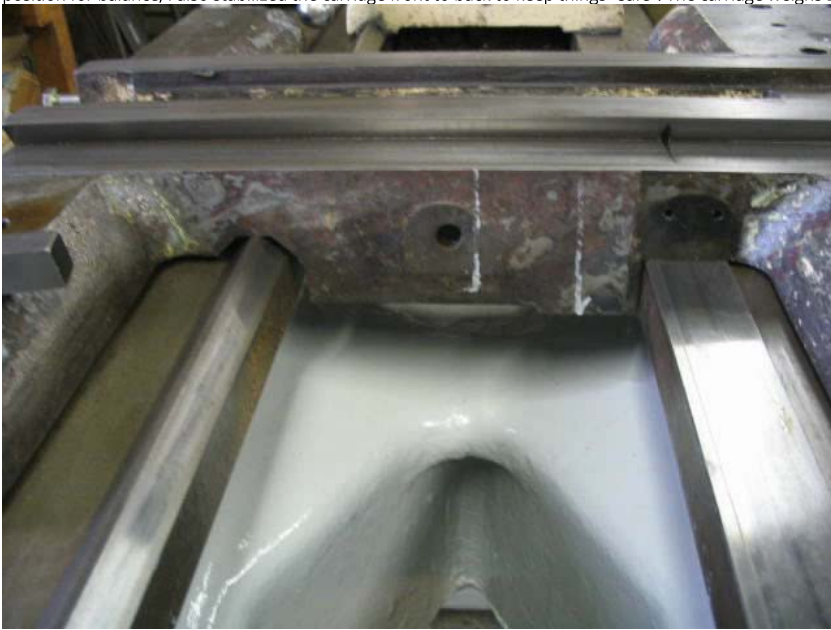
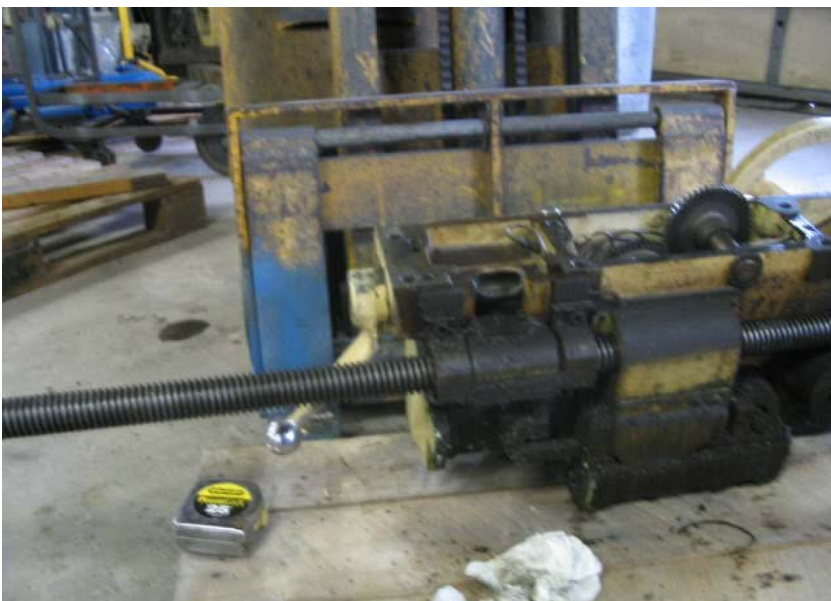
Notice the amount of clearance between the inside bed way and the carriage, approx .003" on the TS end, which decreases at the headstock end. The inside flat way exhibited the same type of clearances. The white denote the strap position for balance, I also stabilized the carriage front to back to keep things "safe". The carriage weighs 212 LBS.

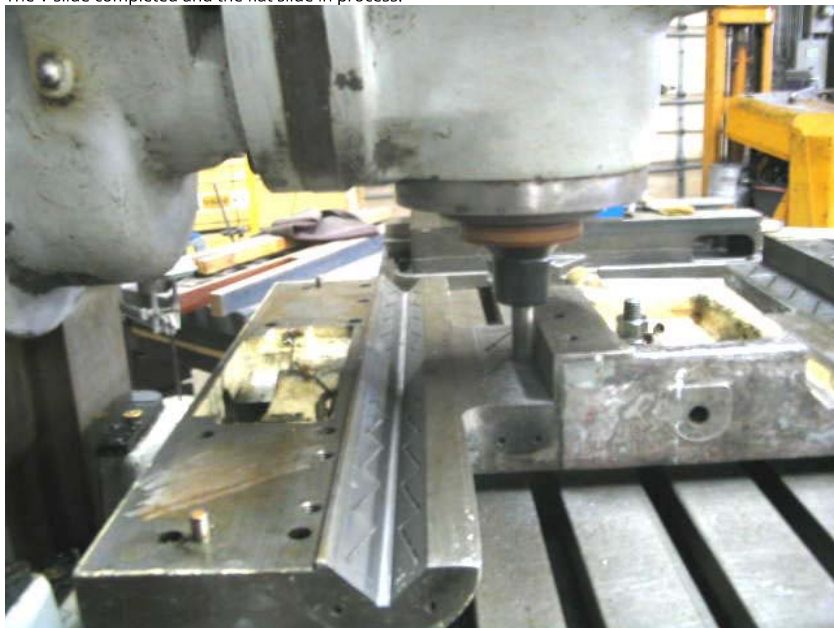
Today I put my #4 Cincinnati to work, along with the first use of the vertical head that I've been tripping over for a number of years. I increased the clearances in the V slide groove and inside flat slide by approx .015- .020", and the bed's inside V way clearance by about .040". The milling took 2 set up, the first to get the V slide and flat way and the second rotating the carriage 180* to get the bed's V way clearance. The V slide completed and the flat slide in process.

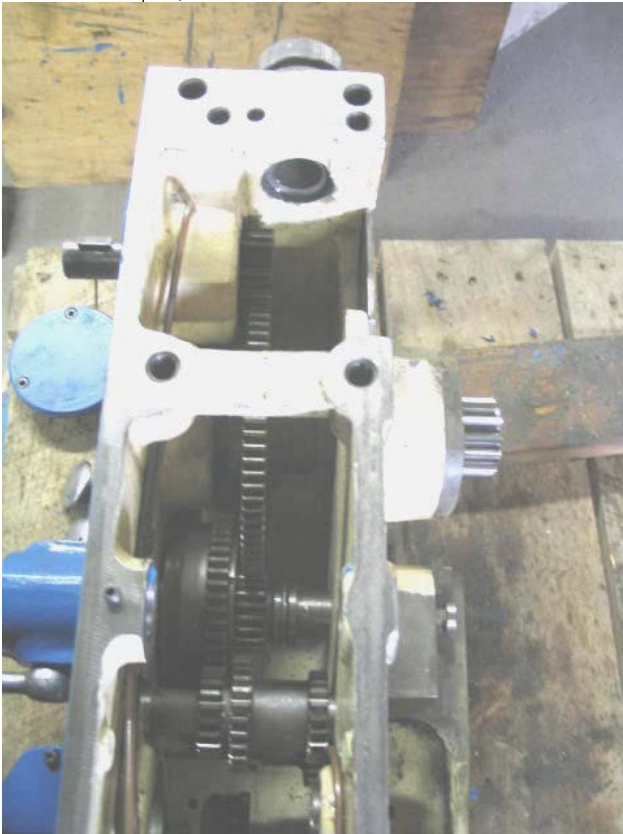
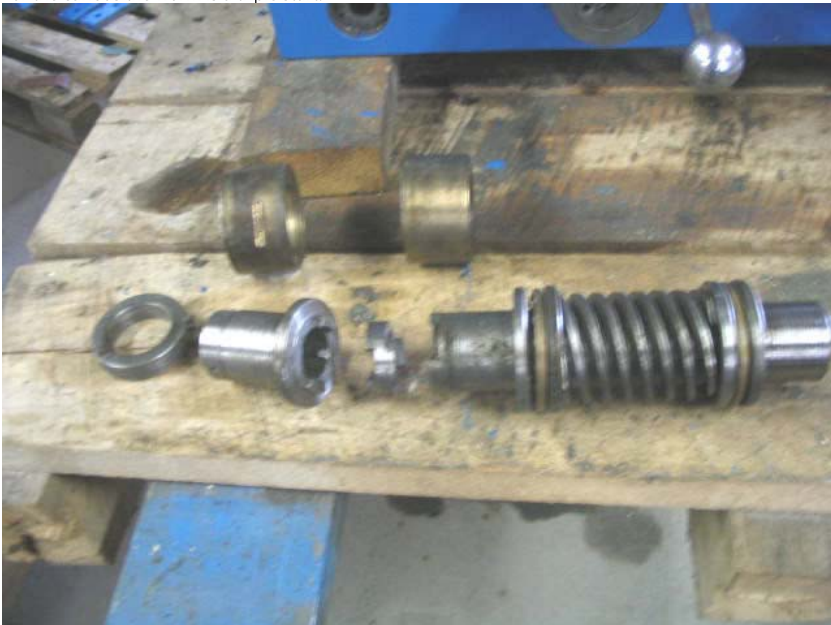
The apron's worm with thrust bearings, on right, the drive plate, center, and the driver, left. The respective bushing are behind, with the right side bushing still in the apron.

The driver and the bushing need to be reworked to account for a lot of wear. I'll turn the driver, bore and sleeve the bushing, and then re bore to fit the driver. There is some wear on the drive dogs, that still I'm deciding what the best way to approach them is.

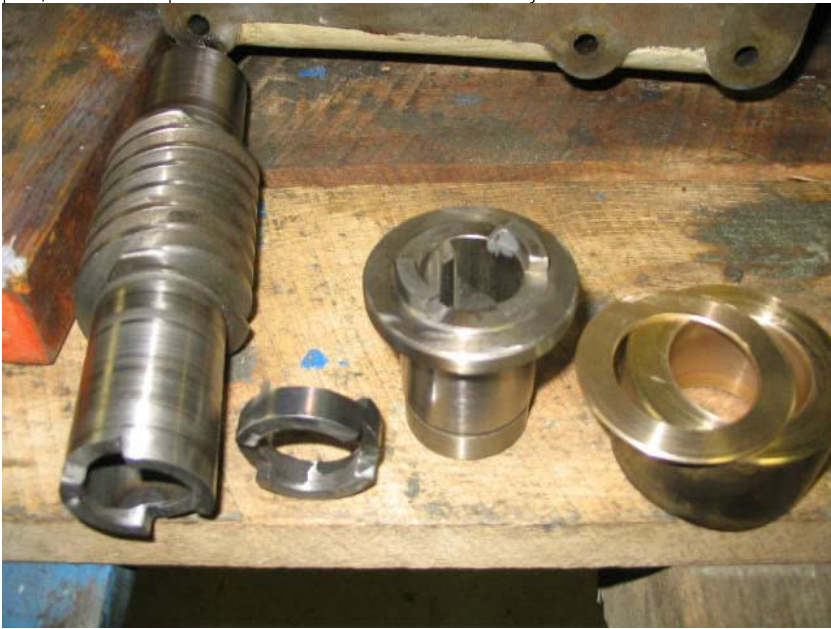
The worm drive parts have been rebuilt. A friend has a tenant that specializes in microscopic welding, and I thought that had some possibilities. He used, IIRC, H13 rod to build up the worn areas in the dog teeth of the drive parts. I considered setting the parts in the mill and lathe, but decided to see how I was at free style die grinding. It may not be pretty, but it was a lot faster. The bushing for the driver was bored, a sleeve made and pressed in and then bored to a .002-.003" clearance for the resurfaced driver. I also made a spacer for the bushing, to replace the lost material from wear and refacing, to get rid of the axial slop. The bushing has a locating pin for the spacer, and to prevent the spacer from turning with the driver. Think of it as a bronze thrust washer for a bronze bushing. I'll reassemble the drive in the apron in the next few days to

cutting with the driver. I think of it as a bronze thrust washer for a bronze bushing. I'll reassemble the drive in the afternoon the next few days to test everything out, and make the necessary adjustments. I haven't decided what to do about the tapered bores in the worm and the drive plate, but I think this problem should be addressed in order to delay the inevitable wear that will occur.

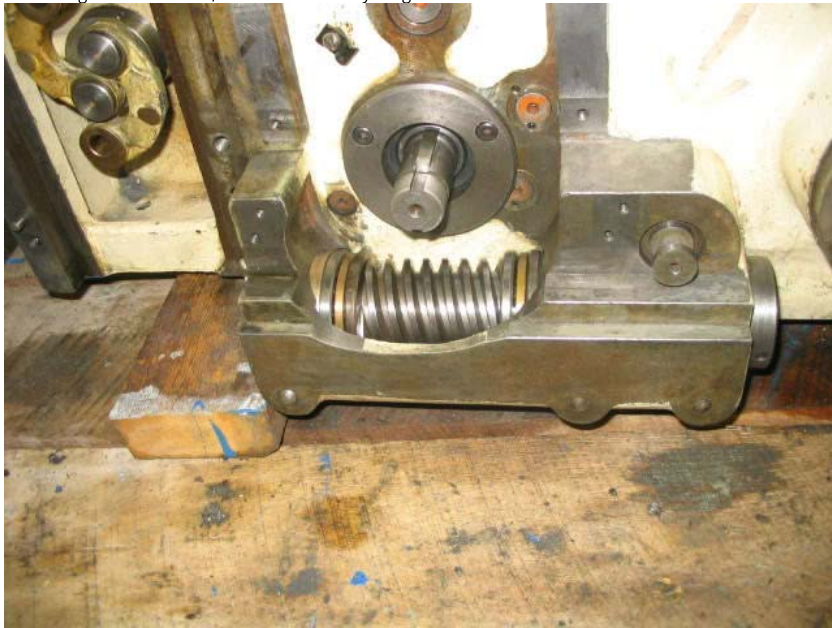
Test fitting the worm drive, to make sure everything works.

Today, I bored the worm bushing in the same manner as the first bushing, for the same type of repair, and turned the end of the worm for a good surface, allowing for .002-.003" clearance in the assembly. Once the machine work was done, I tried to assemble the worm, thrust bearings and bushings in the apron. I did "permanently" assemble the TS bushing in the apron. Then I tried to insert the worm, in the bushing. It would barely start, and go no further. I screwed around with this for next hour to no avail. Finally, took the TS bushing out, and removed about .003" from the bore, and polished off approx .003" on the worm. Reassembled the drive, and it finally worked like it should, only this time the .020" slop was gone. The only thing I can figure, is that yesterday I didn't have the taper driven home, and today I did. So, I've got an assortment of arbor shims for my 1-1/2" arbor, that I'll probably never use. Gee, I wonder how we come up with so much stuff, that we never use.

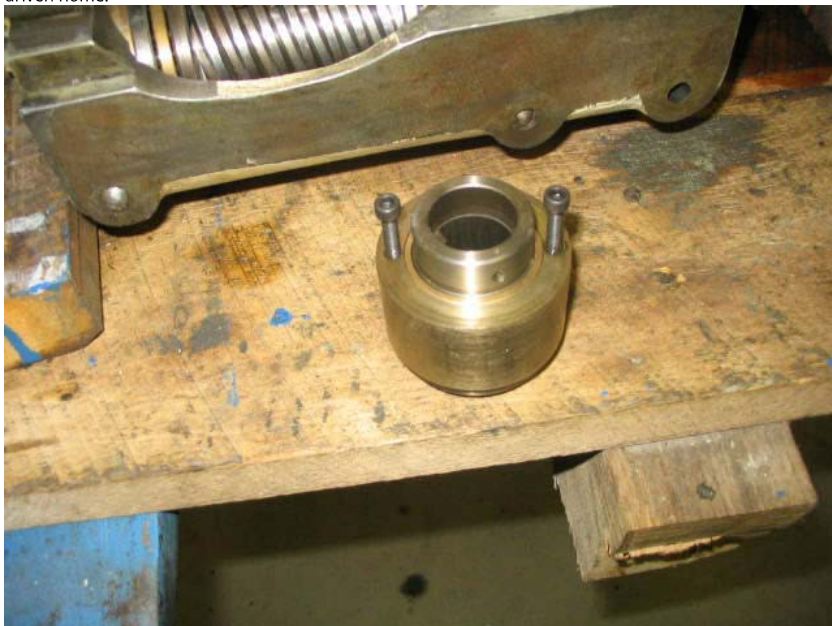
Each of the 3 bushings has 2 10-24 tapped holes in the headstock end. I assume the holes are for withdrawal purposes, but I used them with screws inserted for rotating the bushing for the taper pin slot alignment with the taper pin hole. You can see 2 taper pins in the apron, already driven home.

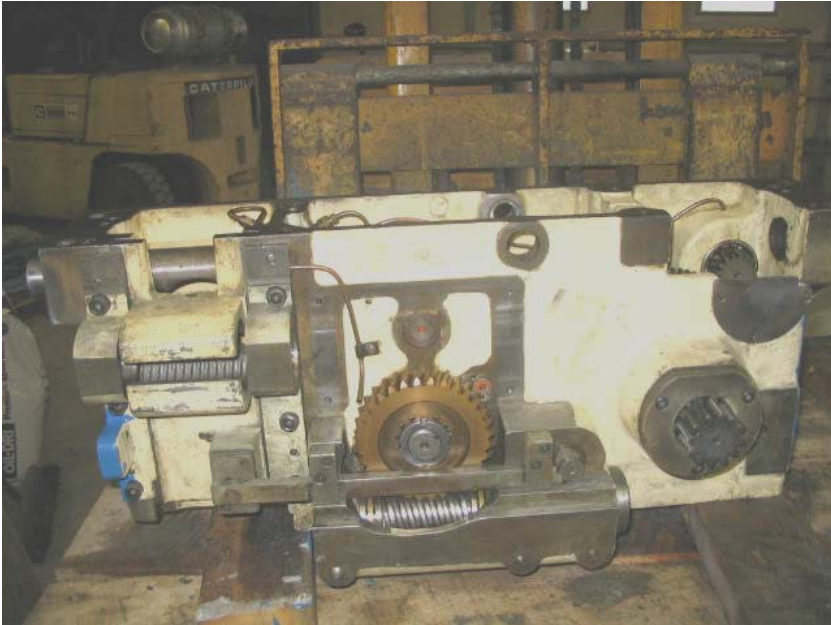
The back of the apron less the cover for the worm gear. The horizontal bar is the half nut/longitudnal feed interlock. Notice the oil drip line over the worm gear coming from the right half nut bracket. Both half nut brackets have wear bushings for the leadscrew. I made new ones from 4140PH, as the originals were severely worn from the sag of the leadscrew. The tube, in the upper left, over the half nuts is for the leadscrew reverse shaft.
