Another New Toy

In another topic in this forum, I mentioned that I had to rearrange the shop for a Series 60/61 16 X 78 lathe. The lathe is a little short of 13' long and about 4' deep and weighs approx 9200 LBS. I looked at the lathe approx 2-3 months ago, before it was listed on ebay, and had to decide if I could live without it, but most importantly, where to put it. While I was making my decision, I called my rigger to see if he could lift it, and he also quoted me a price, which was extremely reasonable. By the time I made my decision, the seller had listed it on ebay, it didn't sell, and then it went into his stores category. I contacted him a couple of times, and apparently he an offer, but the buyer didn't pick it up. One of my friend's is the seller's former employer, we all keep in contact and communicate and he told me the seller's bottom line, which was a tad bit more than I was thinking, but not unreasonable, and definitely not any where near the ebay price. I paid the bottom line, apparently I'm not the thief the seller thought I was.

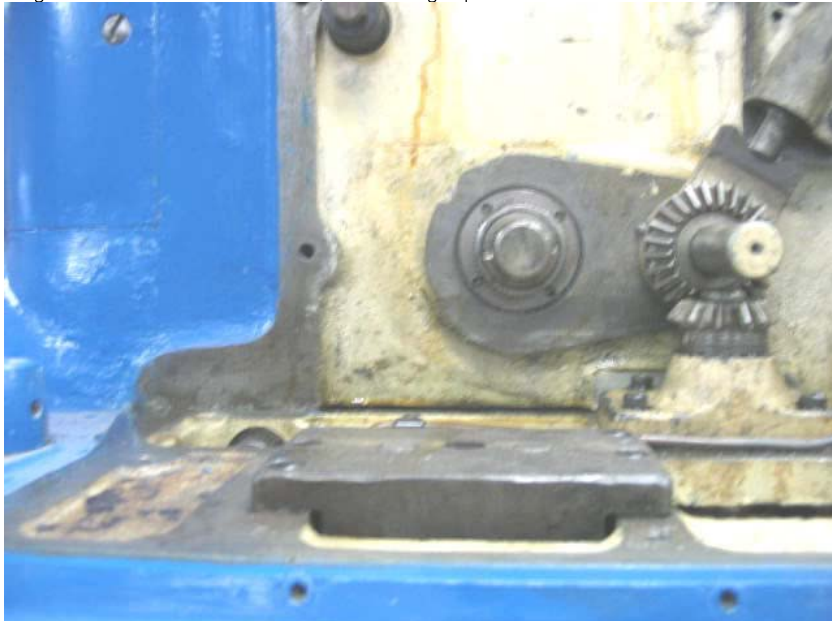
In order to do the above, I had to take the front covers off the headstock and the top of the gearbox, and I just happened to notice an oil seepage problem around the speed shifters. This is not an unusual problem with older Monarchs, I think every one I've had has leaked around the shifters, it's just harder to find when the shifters are covered up, as they are on the SE60's & 61's. On the C series it's easy to spot, just look under the shifters for the oil seepage.

Left side speed shifter shaft and shifter tube. The center shaft shifts one pair of speeds, the ring on the OD with 2 spanner grooves is a packing nut and screws into the shifter tube, it's the ring around the nut, for the other pair of speeds. The ring with 4 spanner holes is the other packing nut and screws into the headstock casting. The tube and shaft have splines for the shifter hubs. If these nuts are loose, and they can and do work loose, oil seepage will result. The same set up on the right hand side shifters, as well as the leadscrew reverse shaft(with the bevel gear). All of these shafts are below the headstock's oil level. I toyed with the idea of using Loctite on the nuts, but I'm using pipe dope. I think that it will give the correct amount of adhesion, without being so permanent as Loctite. Time will tell.

The leak/seepage repair seems to have worked. All that I have noticed is an occasional extremely small bead of what I think is excess Loctite working it's way out.

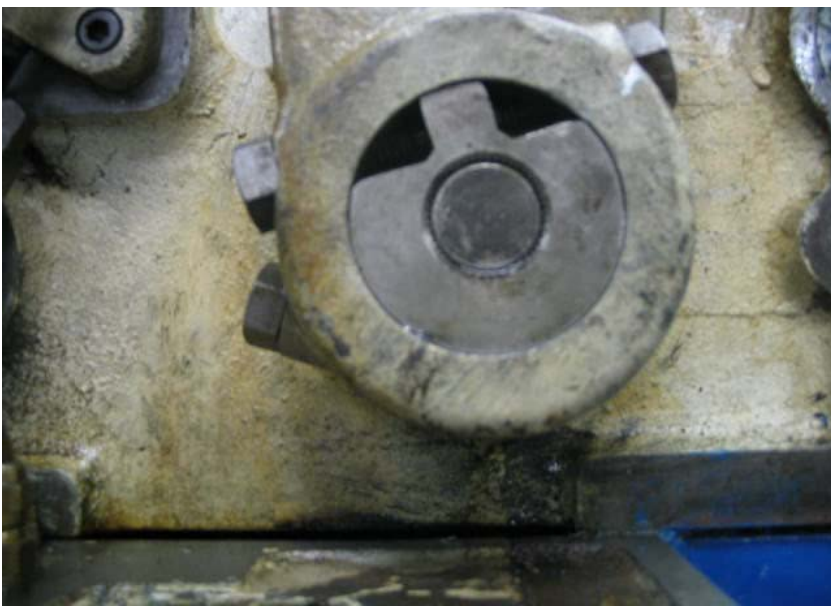
These are the right side shifters. You can see the oil seepage at the bottom of the shaft and shifter hub.

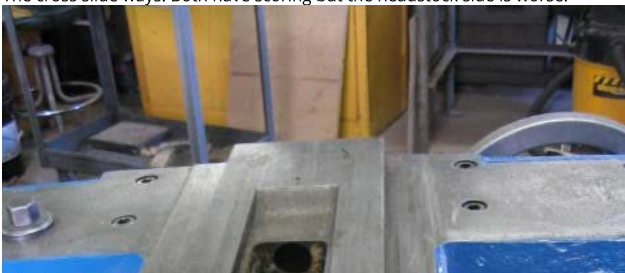
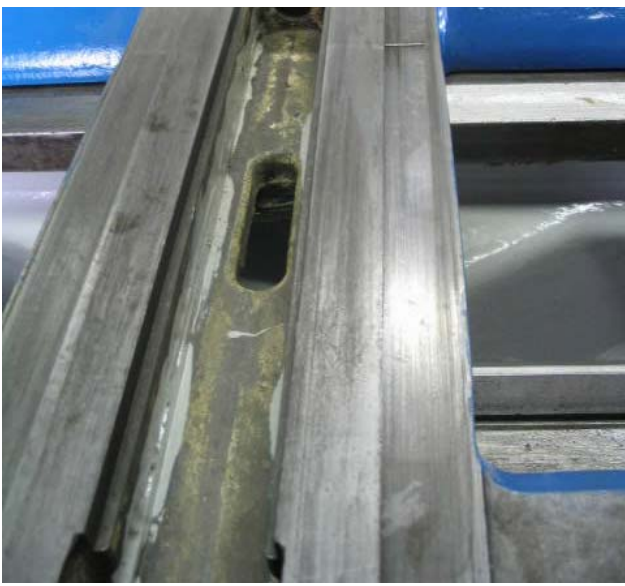
The cross slide ways. Both have scoring but the headstock side is worse.

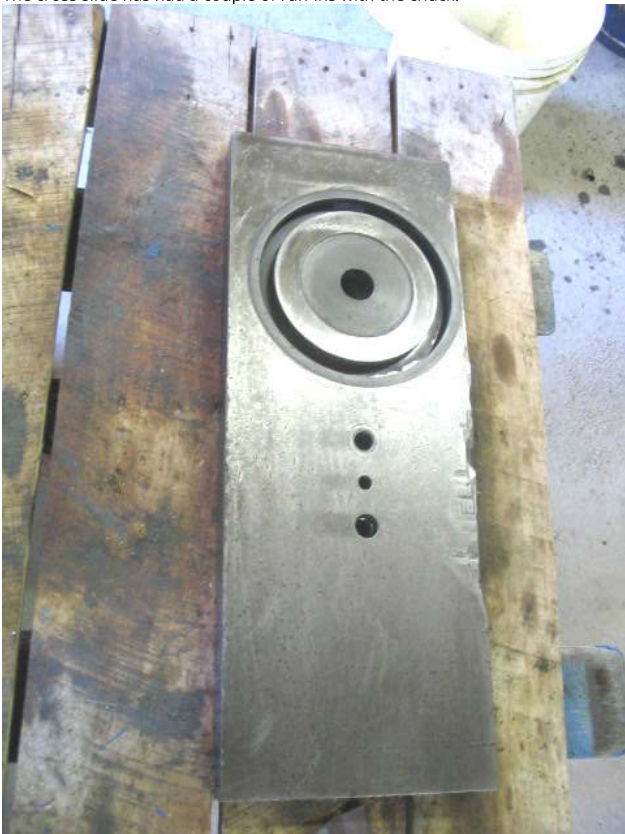
The cross slide has had a couple of run-ins with the chuck.

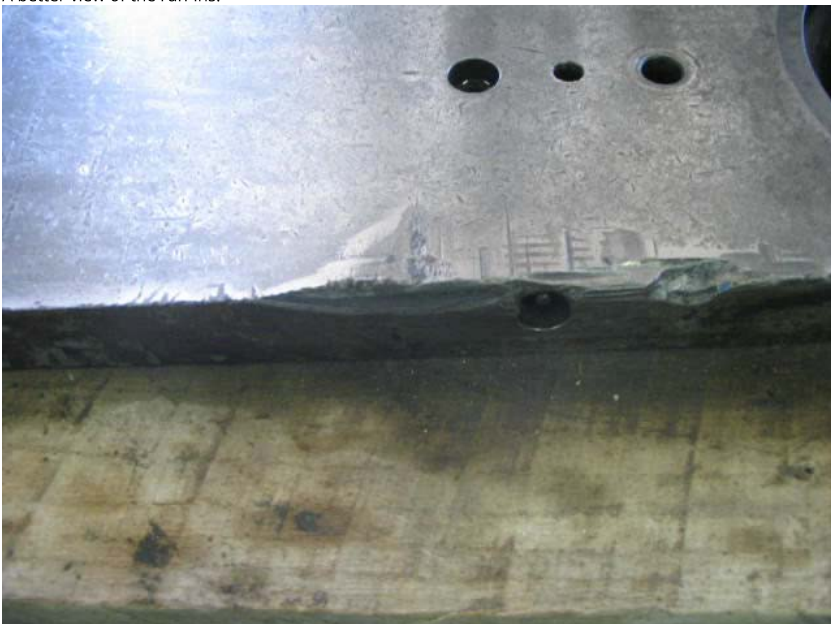
A better view of the run-ins.

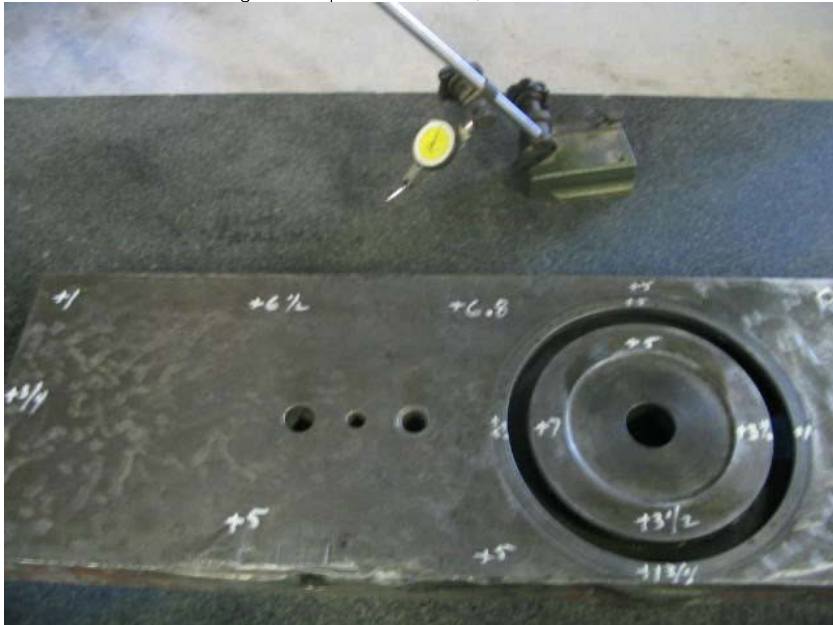
These are the indicator readings of the top of the cross slide, the numbers are thousandths of an inch.

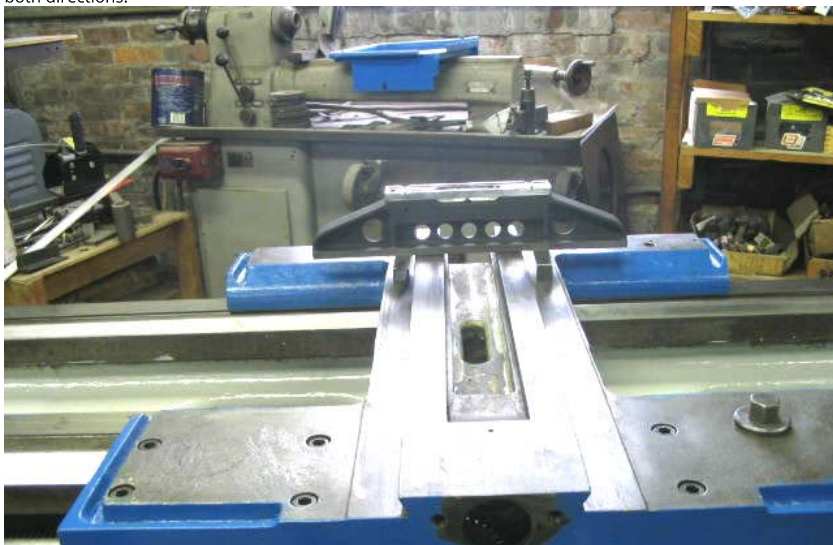
Surveying the cross slide ways. The ways were checked longitudinally and transversely. They are high in the right rear and low on the left front, the left side is lower than the right side. The objective is scrape the cross slide ways so that the level reads the same as it does for the bed, in both directions.

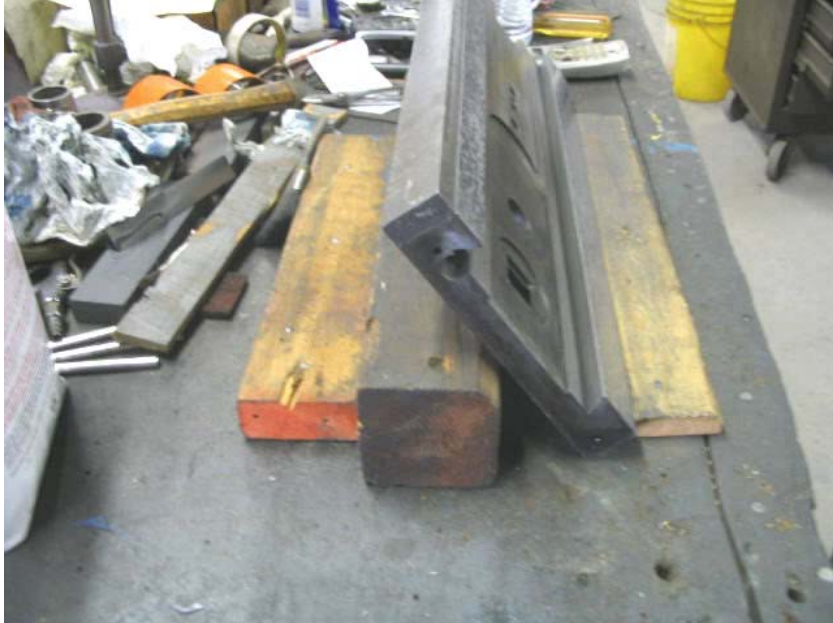
Set up for scraping the cross slide's guiding dovetail slide. Needed to get the slide in such position that I could see it, and not stand on my head.

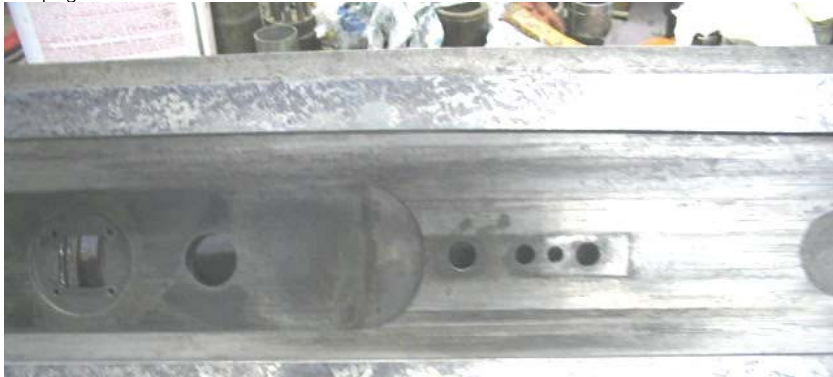
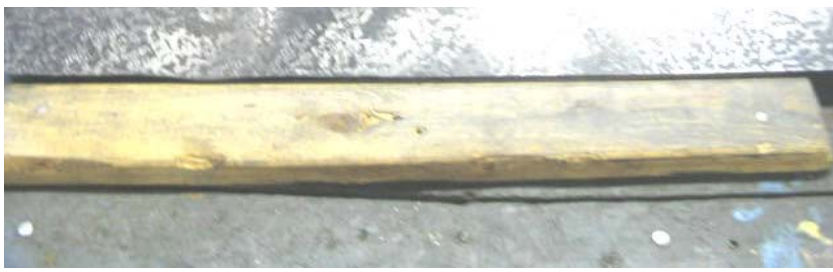
The 3 holes on the right are for the cross feed nut. The 2 outer are for the screws, the center is an oil galley that oils the nut and screw. There is a hole on the headstock side, that is visible in an earlier picture, with a grease fitting. The hole to the left of the 3, is for the TA's drawbar clamping screw.

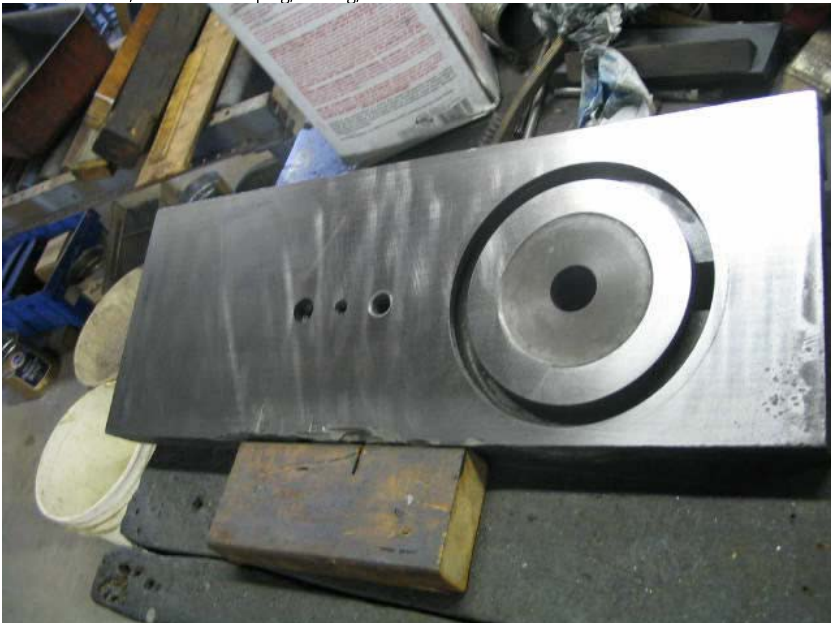
After consulting with the grinder about the issues that Dave(rimcanyon) raised, about warpage, I decided that it was still in my best interests to get the cross slide ground. I concluded that it was far easier to correct a minor warp rather than scraping .006-.008" off the top. Yesterday he picked it up, today it came back, and the bill was a little over half of the original quote(surprise, surprise, that's never happened before). I conducted 2 tests on each side, the swivel test on the surface plate, and with the DTI. The ground side did not swivel, and the DTI was within .0002", the slide side had a bit of swivel, but the DTI was still .0002". I found the high spot approx in the middle of both slides and scraped them out. The high spots showed up as bright spots on the scraped surface, and it was relatively easy to see them and pin point scrape them off.
The ground top of the cross slide. I don't particularly care for the feed stripes, but they will less noticable in a few months. The grinder followed my instructions to the letter. I told him to clean it up until the compound rest area way area way good. If the ends don't clean up, don't worry about it. It is flat, there is no warping, bowing, etc.

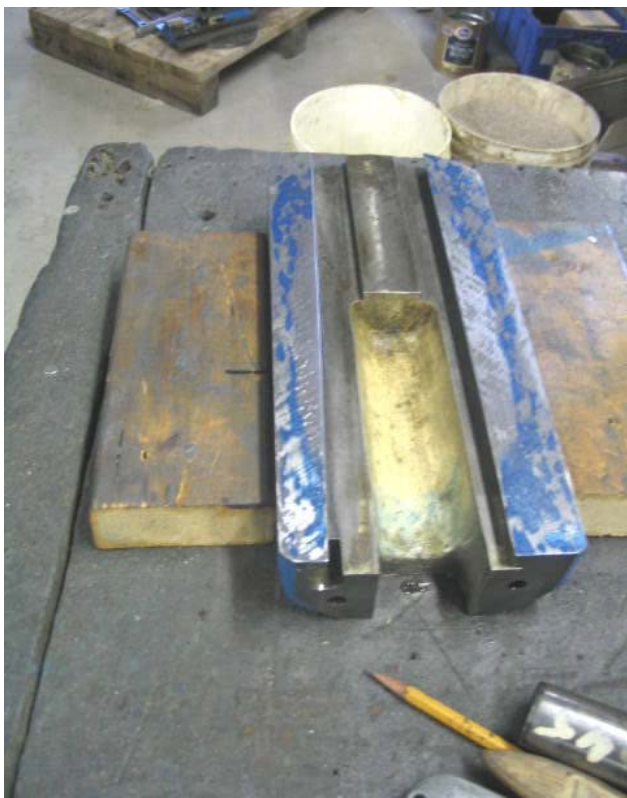
While I was waiting for the return of the cross slide, I scraped the the swivel slide of the compound rest, and got started on the compound top's slides. This is about the 7th cycle on the top's slides. When I started the spotting was only on the 4 corners.

With regard to what I'm seeing on this compound, I don't think what I started with can be totally attributed to wear, perhaps there is a bit of age related stress relieving, or maybe there was a lot short movements. I'm just dealing with what I find. I wasn't planning on doing the swivel or the compound, it's already been painted, but I had a little free time, and thought I'd check it out. Now, I got a little extra to do. Go looking for trouble, and I'll find it.

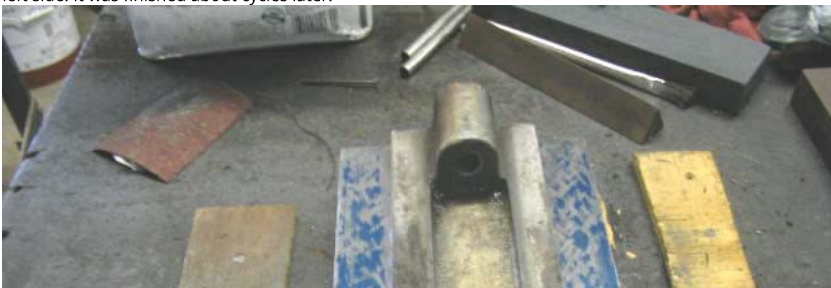
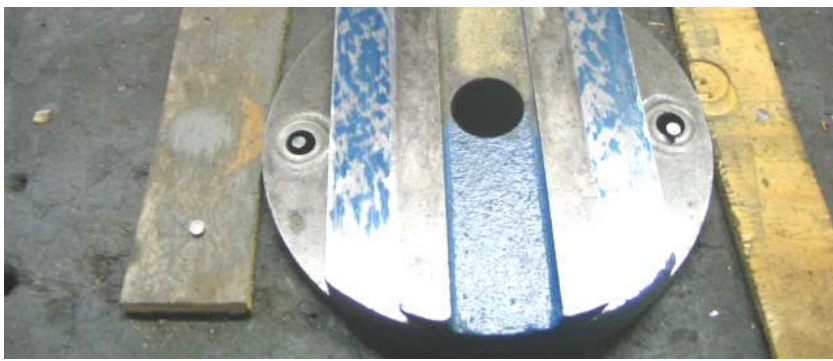
Spotting the top slide ways, about the 7th cycle. When I started the spotting closely matched the bare area in the 2nd picture of my 4-11 post. Every so often I will check the parallelism on the surface plate. The spotting sequence used the the top slide's slide for 2 cycles, then an angled straight edge for 2 cycles, to get ubder the dovetail. This spotting was done with the top slide. You can see where the tapered gib goes on the left side. It was finished about cycles later.

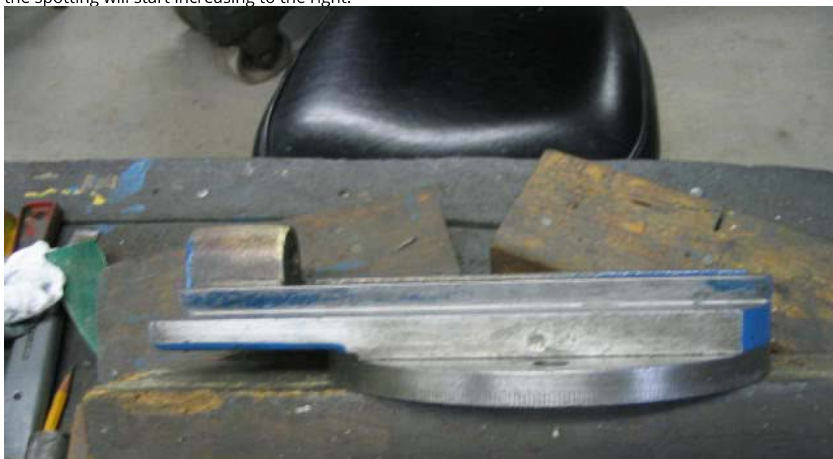
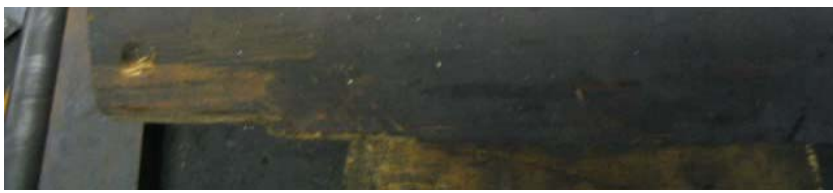
About the 4th cycle, also a better view of the integral nut. The left side needs approx .0015" scraped off to obtain parallelism. As this progresses the spotting will start increasing to the right.

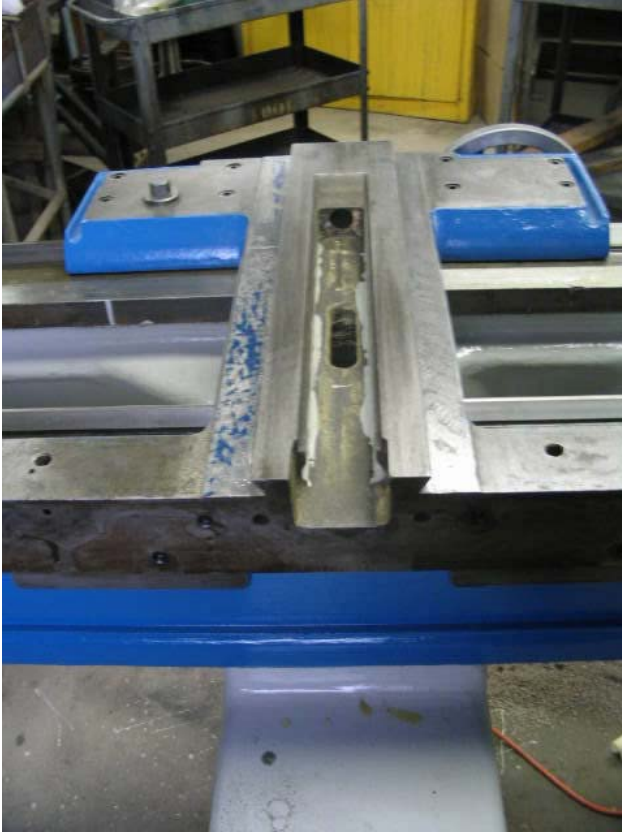
The original clearance between the cross slide and the carriage in the area between the dovetails must have been no more than .003". The cross slide was in contact with the top of the dovetail ways. In addition the wear difference between the headstock way side and the tailstock way side, was about .002", as measured from the top of the dovetails to the ways with a dial depth gauge, and very consistent. I know I didn't scrape off very much on the cross slide's slide to get them flat, the time was spent in getting them into shape to use as straight edges. Once I discovered that above contact was being made, the hard part was deciding which way to attack this problem. One avenue was to remove the material, about .015" from the top of the carriage, but that would have necessitated the removal of the carriage, or scraping it off, and reworking the TA drawbar, none of which I was not interested in doing. The other avenue was to remove the material from the inside of the cross slide, which is the avenue I chose.

The first spotting of the cross slide ways with the cross slide. This is definitely not what I expected to see. There was no spotting on the headstock side of the ways. This was when I discovered the contact between the cross slide and the carriage, and was not scraped.

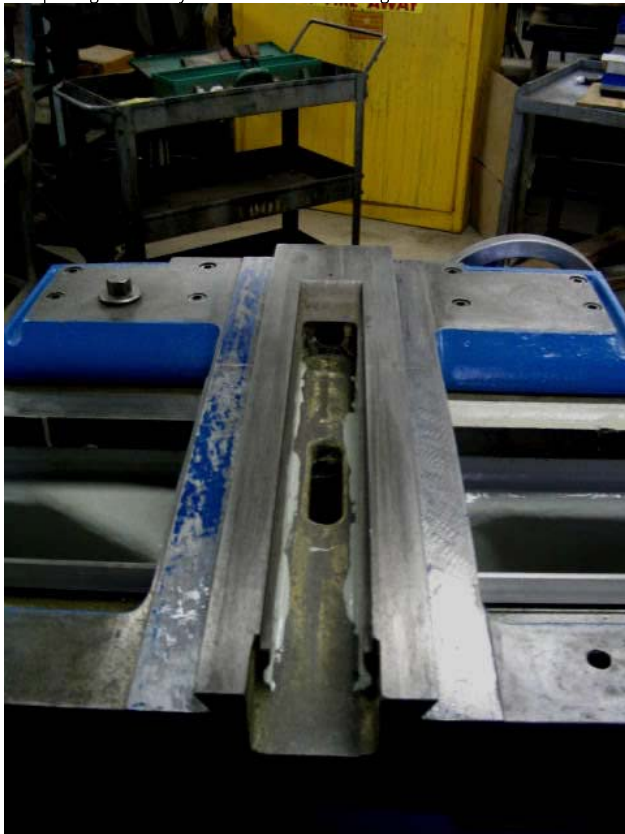
This is the first spotting with the reworked cross slide. Notice the big difference in the spotting pattern on the guided side, from today's first picture. There is some spotting on the guiding side, mostly under the dovetail. I've darkened the picture some, and you've really got to look for the spotting. It's mostly next to the dovetail's edge.

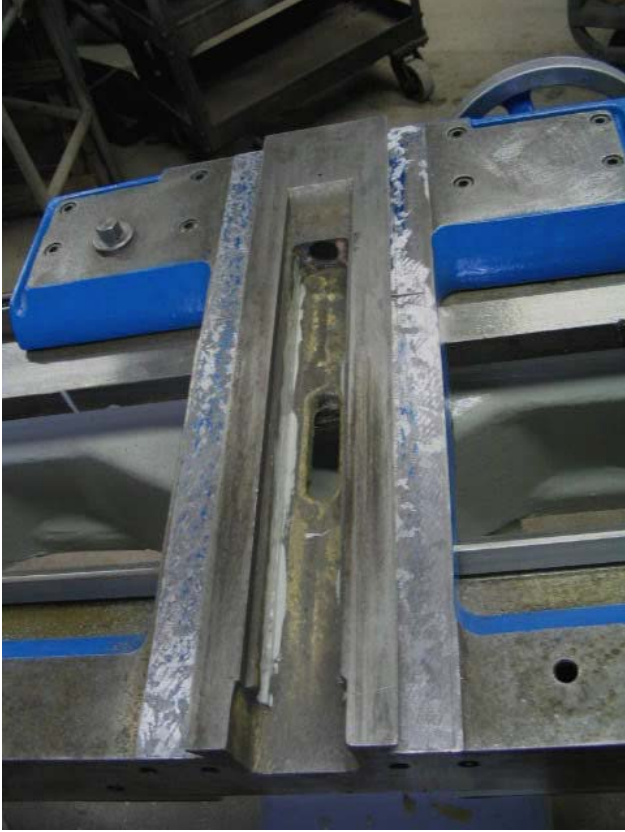
Progress is being made. This is about the 9th cycle. To speed things up a bit, I used the angled straight edge for several spottings on the tailstock side to get the bulk of the material off and to equalize the heights between the 2 sides. The rest of the spottings will be to improve the bearing surface, and will mostly be done using the cross slide. Checking with the depth gauge, it's closer than it looks.

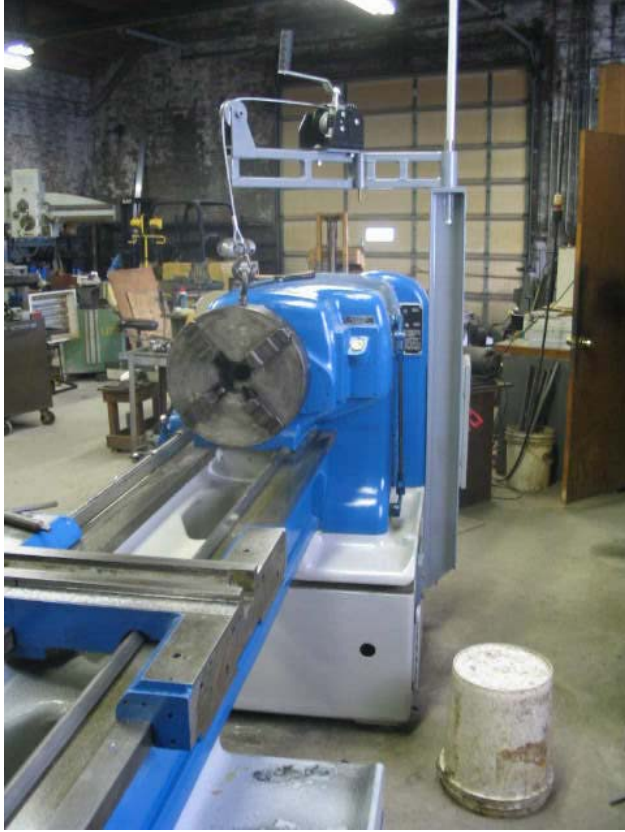
Got the flat ways finished up today, sorry no picture, the spotting was too faint to show up. I could hardly see it, but it was there. The cross slide is out of parallel to the bed ways by about .0015" longitudinally and .005" transversely, from what I could determine using the level. The next step is to take care of the guiding dovetail way, which has to be square to the spindle to .0005" concave/12". This necessitated the mounting of the 4 jaw, and indicating a parallel to be square. This is done by rotating the chuck 180°, and making any necessary adjustments so that a 0-0 reading is obtained. This is also means I have to mount the job crane to mount the chuck. Don't laugh at my crane, I'm not exactly tickled with it, and I do need to remount the winch so that I can get rid of the bucket to stand on.

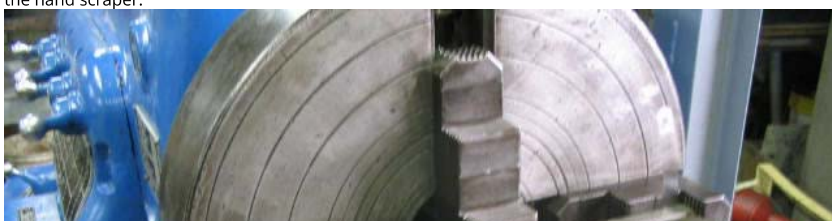
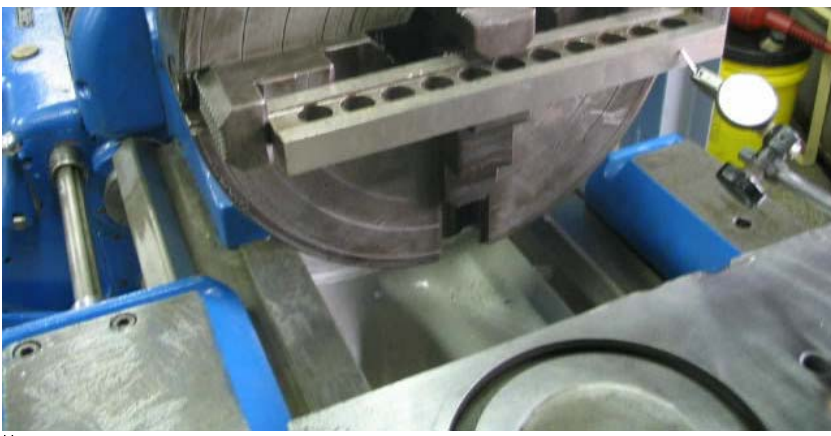
The test is done by starting the cross slide in the above position and moving it to the rear in this picture. It's convex about .005". I've got a lot of scraping to do. The BIAx isn't the easiest tool for me to use when I half standing on my head trying to see what I'm doing. I just may have to use the hand scraper.

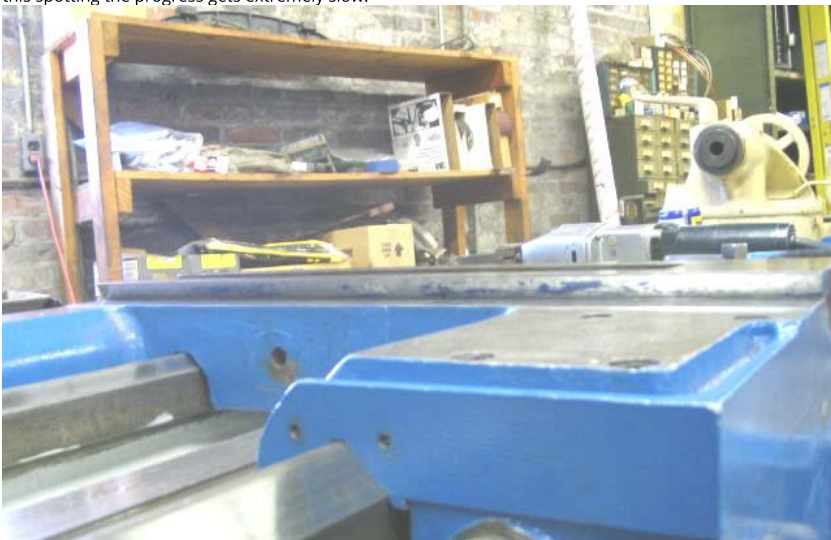
This is about the 7th spotting of the guiding dovetail way. At this point about .003" of material has been removed from the 1st 18" or so. After this spotting the progress gets extremely slow.

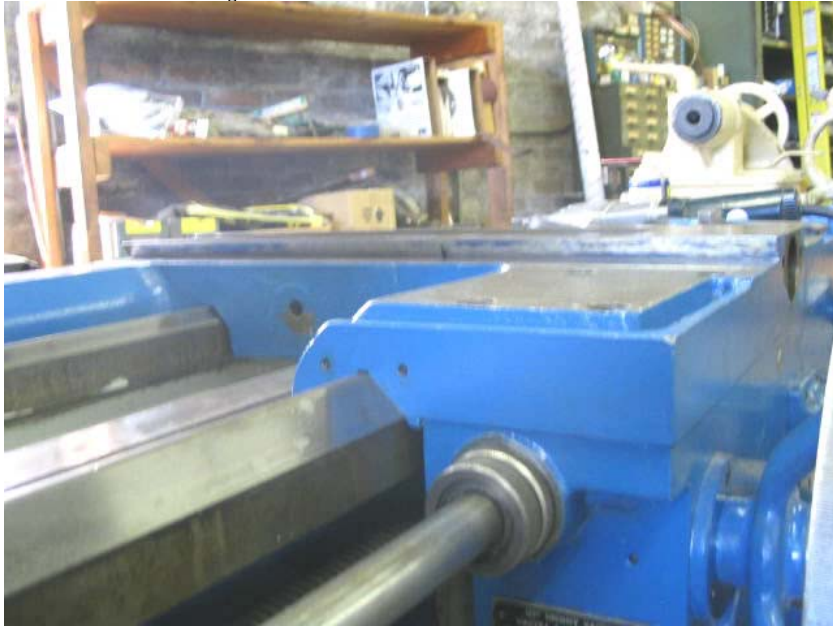
This is about 5 cycles later, and the spotting is mostly staying on the end and very sparse isolated high spots. This is one of the exceptions. There is still about .0015" to go.

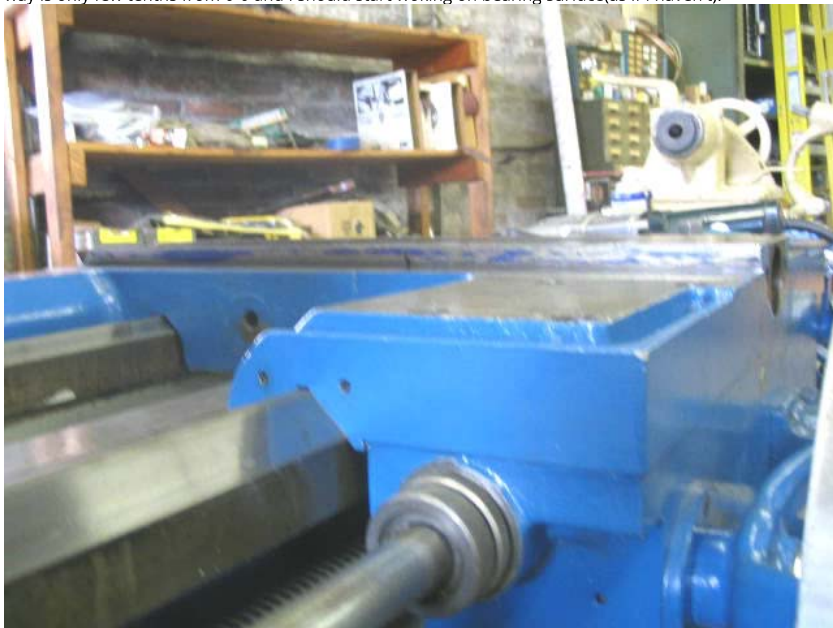
The first 2 pictures were taken Friday, this is from late Saturday morning just before I called it quits for the day. This is about 10 or so cycles later, after a fresh coating of spotting compound was applied. It looks encouraging, but is a bit heavy to be reliable. It was very lightly scraped, and probably shouldn't have been. The very next spotting showed very few high spots, which are mostly on the end. At this point the way is only few tenths from 0-0 and I should start working on bearing surface(as if I haven't).

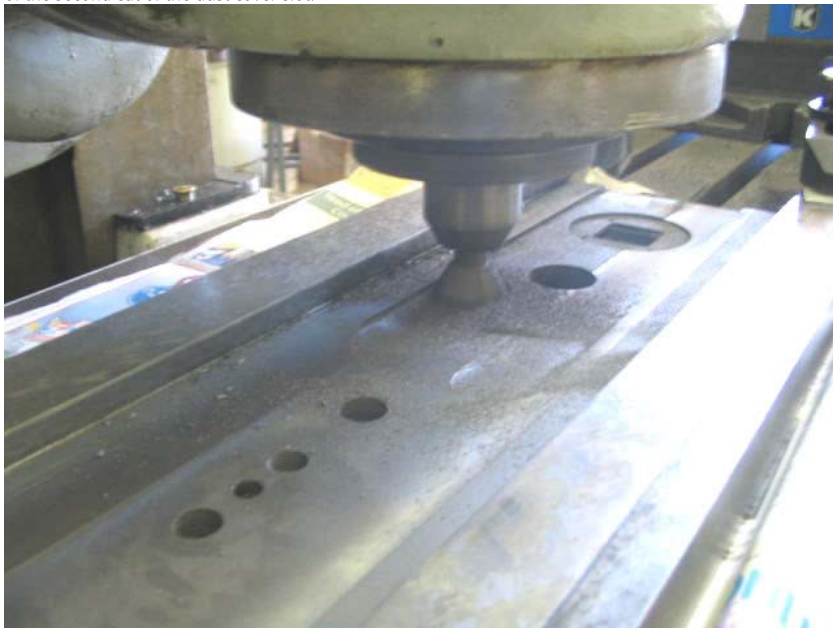
Before I can fit the cross slide gib, which has had a piece of Multifil 426, similar to Turcite, epoxied on, I had to straighten the guided dovetail slide in the cross slide. It had approx a .003-.005" bow. This surface will be scraped before the gib fitting. Back on the Cincinnati for the machining and while the cross slide was on the table, I reset it, and increased the depth the dust cover slot to account for the material removed from the interior. I'll most likely make a new dust cover, as the original is pretty beat up and has approx a .030" bow lengthwise. The picture is of the second cut of the dust cover slot.

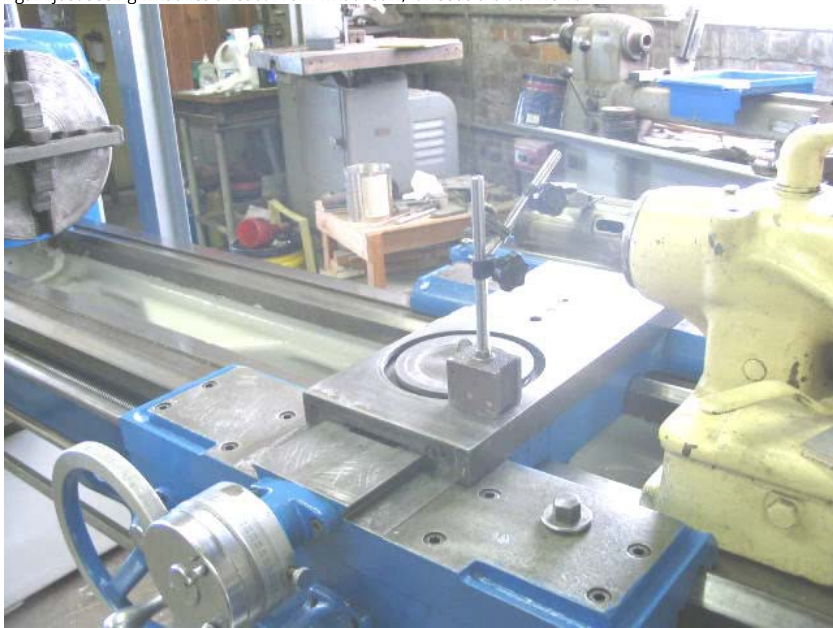
I finally got done with the gib, and assembled the cross slide on the carriage with the screw and did a few indicator checks. The squareness was within .0005"/12" concave in both directions, with the middle 8" being 0-0, apparently the guiding dovetail way is little less than perfect. I also tried to shake/twist each end of the cross slide to see if the indicator moved. On the front no movement, on the rear, maybe .0001". I checked backlash on the screw and nut, and came up with .040", which was invalid because I didn't have the TA's drawbar clamp in place. I also checked for binding in the screw through out the full 11-3/4" travel, the CS wiper is not on so the actual travel will be slightly less, and couldn't detect any. I found that interesting as I was expecting some due to the scraping. I'll have to play with the adjustments a little more, or maybe there is enough wear in the screw and nut that allowed this.

Anyway, I've got to tend to some odds and ends, and then on to the TS.
Again just seeing what lies ahead. From what I saw, it needs a bit of work.

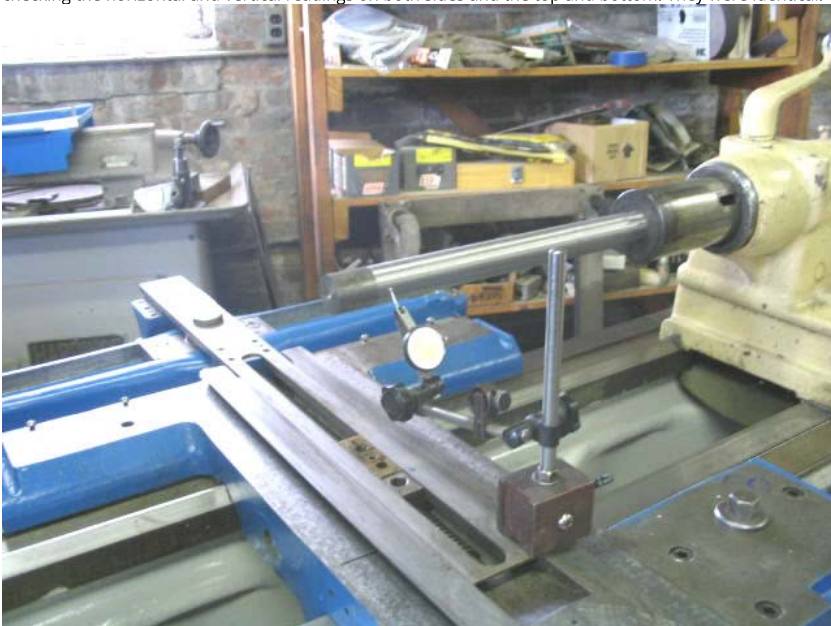
This TS definitely needs some work. It's pointing down at the gearbox approx .010". I did check the truth of the bar by rotating it 90* and checking the horizontal and vertical readings on both sides and the top and bottom. They were identical.

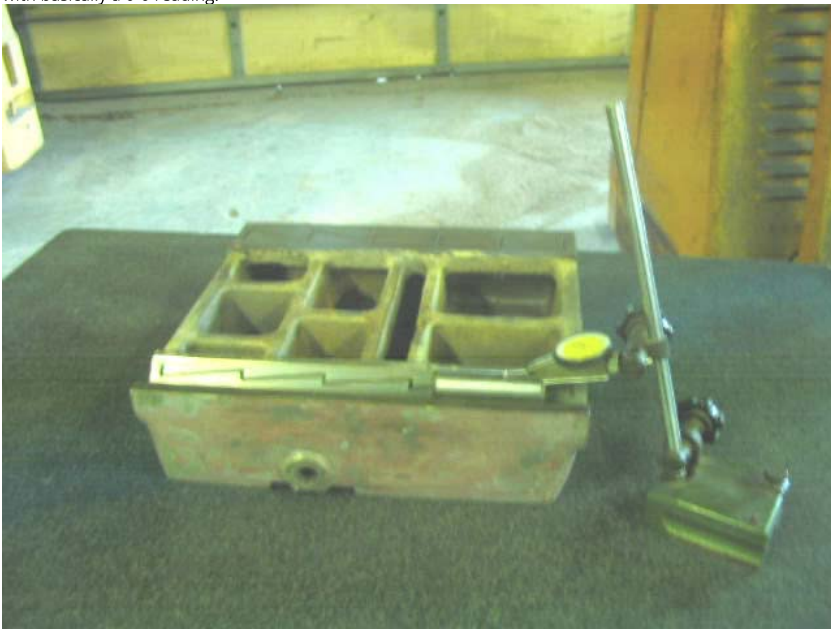
Things aren't as bad as the initial test bar checks indicated. I got the TS off the bed by disassembling it on the bed, removing the taper adjusting screws and the clamping screws, then lifting the top off with a strap looped around the spindle and the back end. The way(s) and slide(s) were quite dirty, which indicates that these pieces have been separated before and not properly cleaned before reassembly. The bottom has been thoroughly cleaned, and then checked on the surface plate and the bed. Checking the V slide on the bottom. The left/right indicator reading was off-maybe .0005", as was the flat slide. I can definitely see where the ways are contacting the slides. In fact on the flat slide the surface is wider than the way by about 1/4" on each side, with scraping marks visible. I ran the indicator across this surface, and the way contact area showed a .005" dip, approx. I also continued this check to the V slide edges, with basically a 0-0 reading.

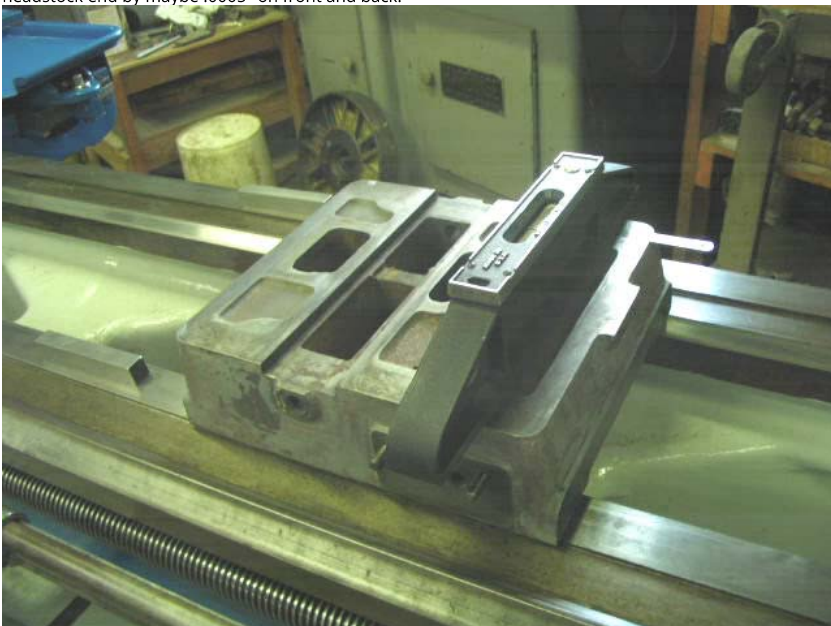
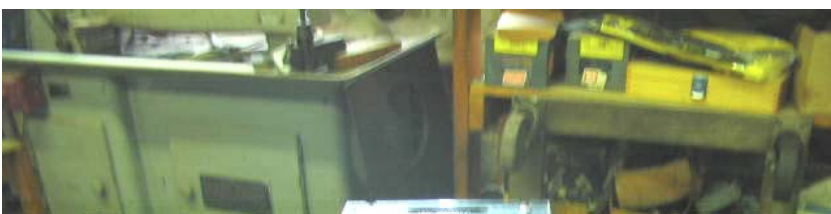
Checking the transverse level. It is high in the front by .008", approx., on both ends. Level was also checked longitudinally, and high on the headstock end by maybe .0005" on front and back.

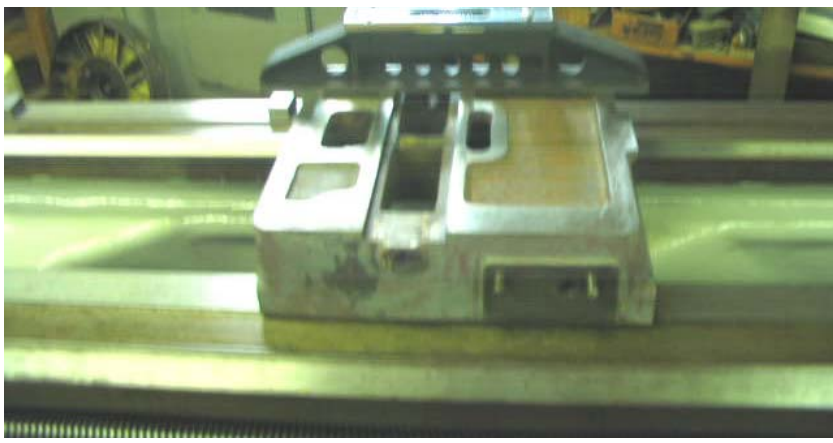
Checking the transverse way alignment. It's off a little, but I forgot how much.

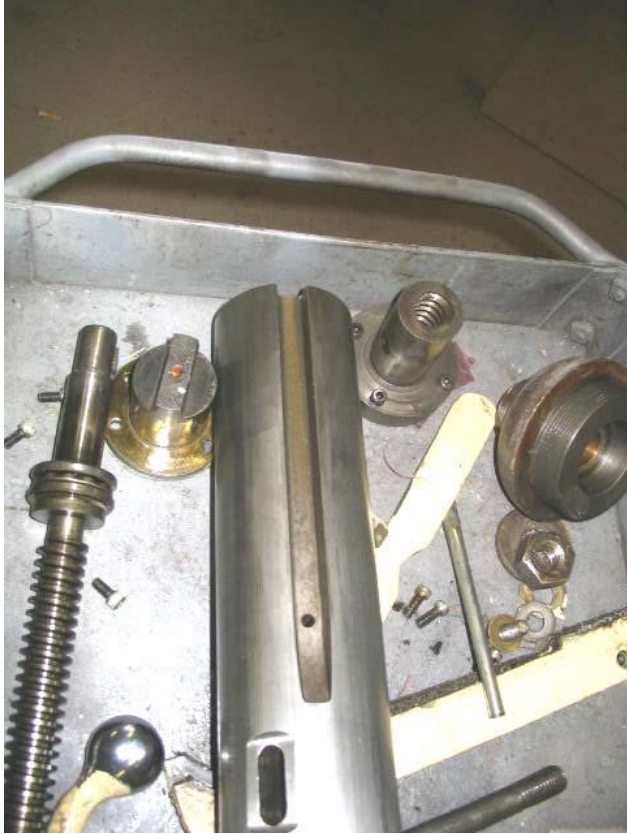
of scraping.
I also cleaned up some scoring in the top's spindle bore, and on the spindle. I had to gently persuade it out of the top.
This isn't a light weight. The spindle weighs 28 LBS, the top 118 LBS, and the bottom 58 LBS.
TS spindle. That's a very healthy key, on the left, and keyway in the spindle. I don't think I'm going to worry about damaging the key or keyway.

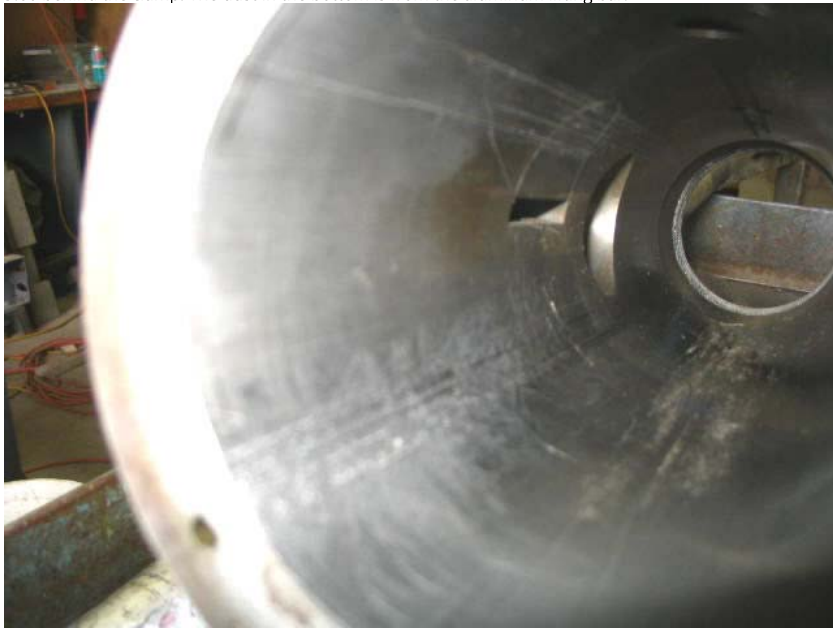
This is looking down the top's spindle bore. There is scoring at 7:00, that I hit with a file, and some at 11:00. The spindle key goes in the hole at 9:00 behind the clamp. The dust in the bottom is from the aluminum lifting bar.

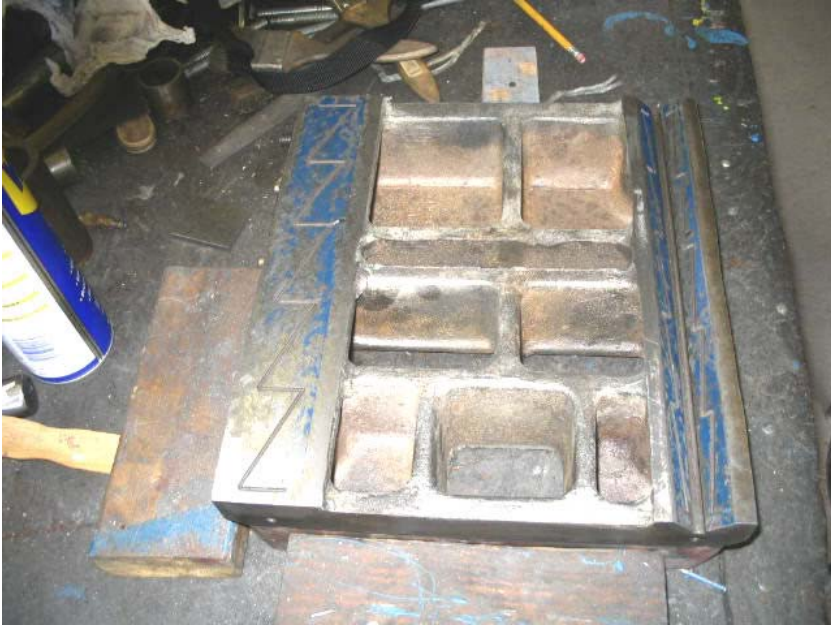
intentionally out of square by .003", pointing to the rear of the headstock, and the bottom is .004" thicker on the headstock end than the tailstock end. I think you can begin seeing my frustration when I discovered the best laid plans go astray. In the end the vertical and horizontal alignments are where they should be, and to get the spindles aligned I'm going to need a .005" shim between the TS's top and bottom. This is very close to the start of scraping on the bottom.

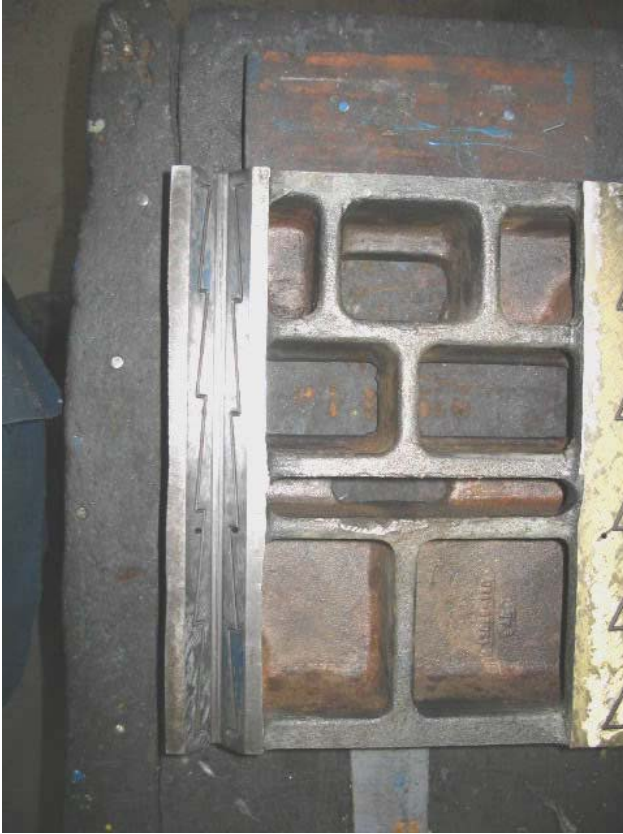
The V slide has been scraped. You can see very faint blueing on the upper left face and lower right face of the V slide. This is intentionally left unscraped as I'm trying to correct horizontal alignment.

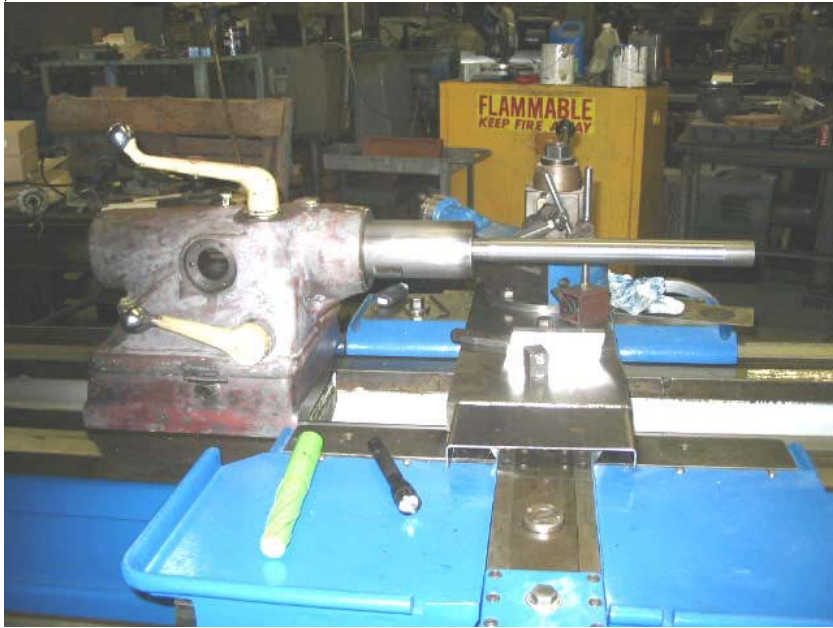
Doing a test bar check. This is the horizontal check, the vertical has been done previously. This particular check was the final check, and the readings are where they should be, and vertical sag has been allowed for. The bar was also rotated to verify its truth, and the tests rerun.

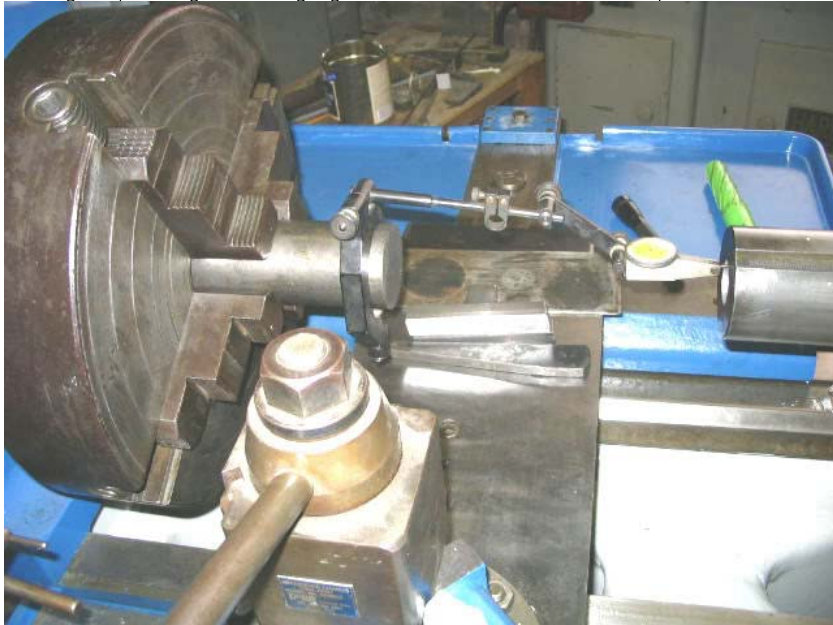
Checking the spindle alignments. I'm going to need a .005 shim between the TS's top and bottom.

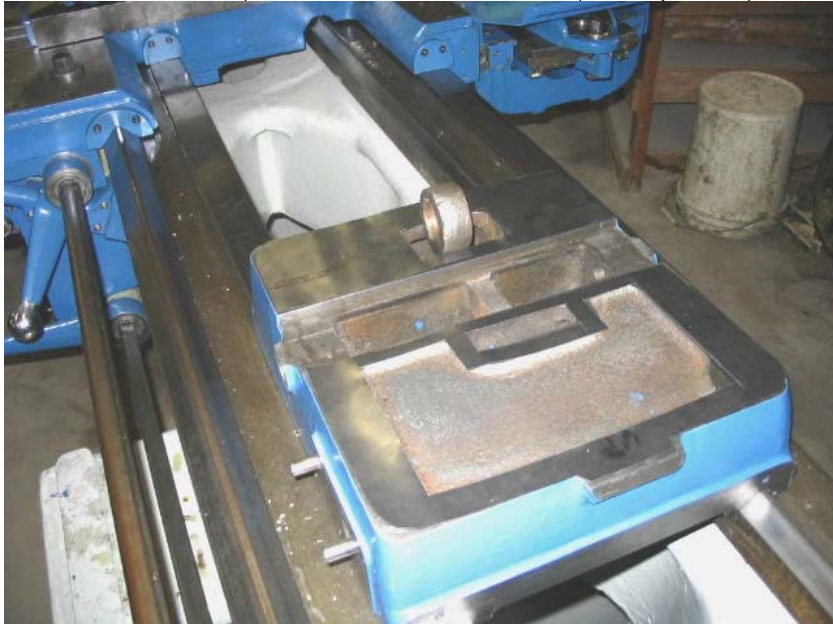
I assembled the TS with a .006" shim between the top and bottom (I've learned every time I shim a TS, I had better add .001" to the number that the indicator shows), and ran the center alignment test. Oops, .017" to high, and the test bar was pointing down. After I settled down, I remembered I had used the wrong indicator for the original test. Ran these tests with the good DTI and it showed approx .011" high, and the same test bar drop. I should have pitched the old DTI a while ago, but it's still functional in certain situations, but not this one. Pointing down was something else, where did that come from. Nothing to do but take it all apart, and see if I had dirt or a crumpled shim. Shims were OK but I did find a glob of paint on the right side under the shim, that explained the test bar dropping. Got rid of the shim(s), and reassembled and ran new tests. I must have gotten lucky in the scraping, because the centers were aligned within .0005" high TS, and the test bar was pointing up approx .0005". I'm going to keep my eye on this for awhile.

This is before I discovered the problem with the DTI. The .006" shims are place ready for the top to be lowered.

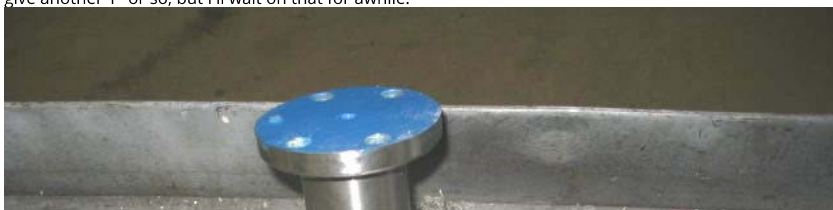
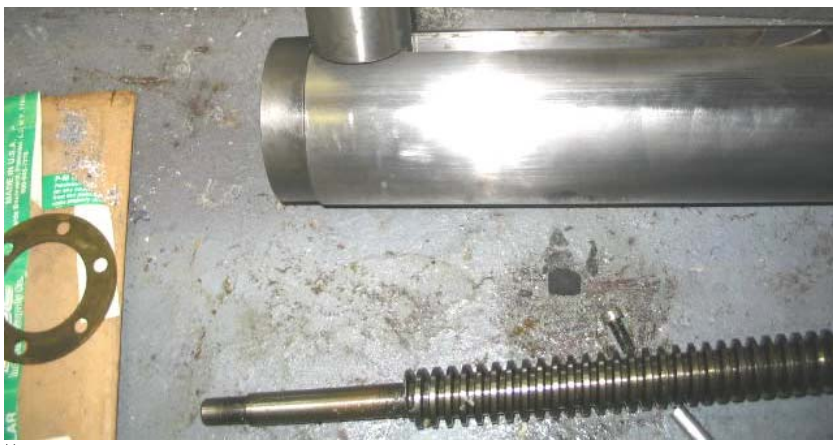
The TS spindle with the nut and key. On my other Monarchs I can get useful overtravel on the spindle, but on the SE 60 there is a hard stop due to the way the nut is mounted, and the very large key. I'm entertaining the idea of cutting out a section of the nut's flange to allow overtravel, to give another 1" or so, but I'll wait on that for awhile.
