Another New Toy

In another topic in this forum, I mentioned that I had to rearrange the shop for a Series 60/61 16 X 78 lathe. The lathe is a little short of 13' long and about 4' deep and weighs approx 9200 LBS. I looked at the lathe approx 2-3 months ago, before it was listed on ebay, and had to decide if I could live without it, but most importantly, where to put it. While I was making my decision, I called my rigger to see if he could lift it, and he also quoted me a price, which was extremely reasonable. By the time I made my decision, the seller had listed it on ebay, it didn't sell, and then it went into his stores category. I contacted him a couple of times, and apparently he an offer, but the buyer didn't pick it up. One of my friend's is the seller's former employer, we all keep in contact and communicate and he told me the seller's bottom line, which was a tad bit more than I was thinking, but not unreasonable, and definitely not any where near the ebay price. I paid the bottom line, apparently I'm not the thief the seller thought I was.

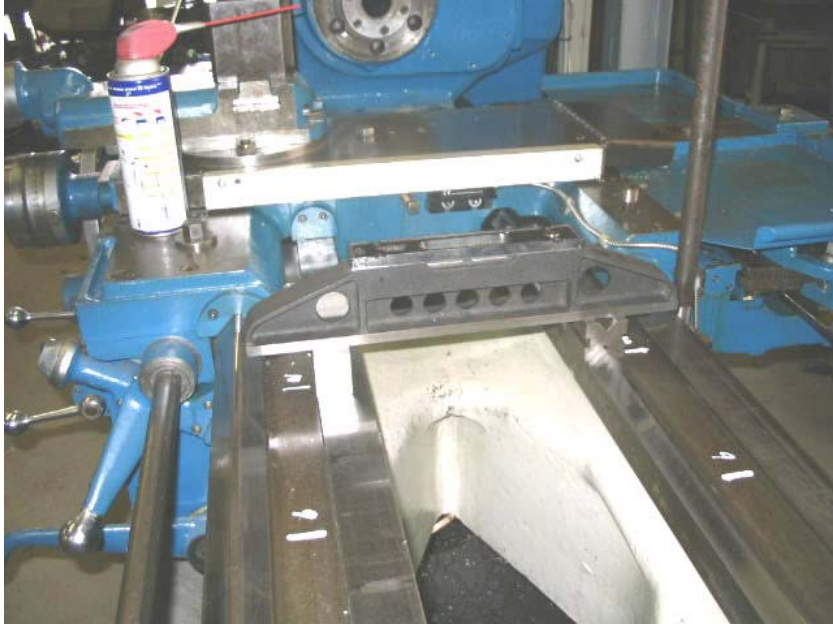
Checking transverse level at 14 positions. This was done for the inside flat way/inside V way and the inside flat way/outside flat way.

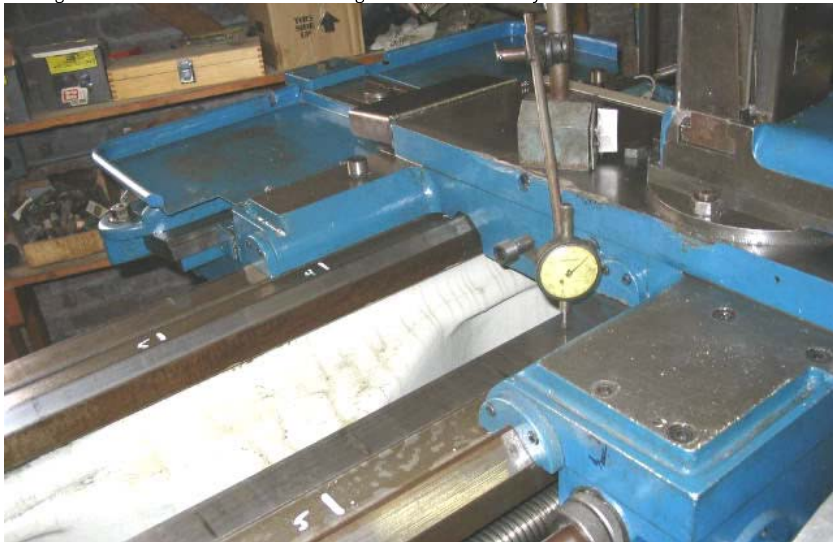
Checking the wear on the inside face of the outside V way. The outside face was checked in the same manner, as was the outside flat way. From position 0-8 the wear is 0, from 8-11 the wear is approx .007", from 11- 13-3/4 the wear is approx .002" going to 0.

from 0-8 0, from 8-11 $\pm .002$ ", actually I think this is 0, but there is a bit of wear on the inside V way at this point, so I get this reading. There was a bit rocking in the V block in this area of the V way. 10-11 0, 11-12 $-.003$ ", 12- 13-3/4 $-.0025$ ". I think these readings are due to a bit of wear on the inside flat from the carriage. The carriage marks are plainly visible.

These numbers have to be viewed with caution. There is definitely a wear factor to be considered in the reference surfaces. Also I was using a travel indicator and wasn't attempting to get exactness, just a good idea of what I'm dealing with and looking for confirmation of the test bar readings. I also ran the check from the carriage to the inside flat way which showed .006" movement in the affected area.

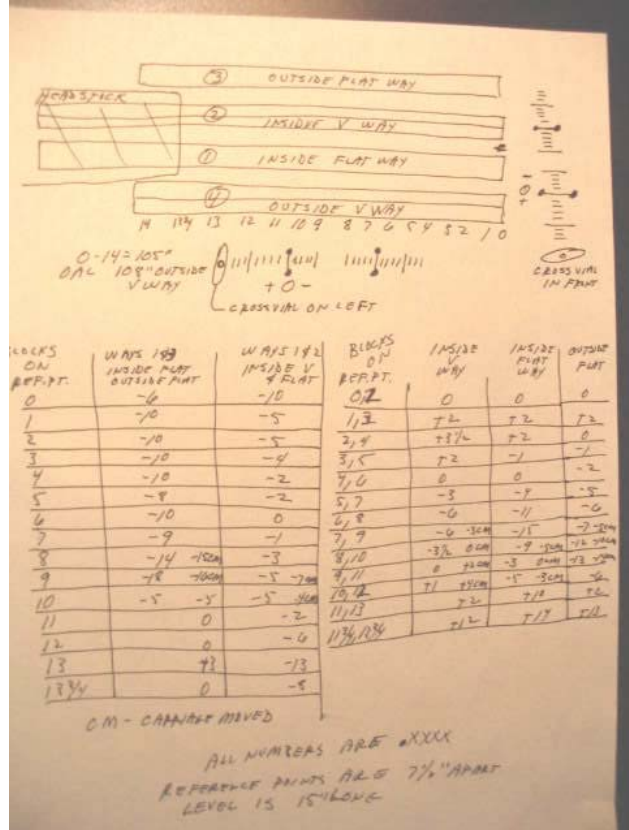
The chart. All the numbers are the 4th decimal point. I hope you can read it. I did have to move the carriage to get readings in that area, and the carriage did affect the readings. Keep in mind the carriage weighs 6-800 LBS.

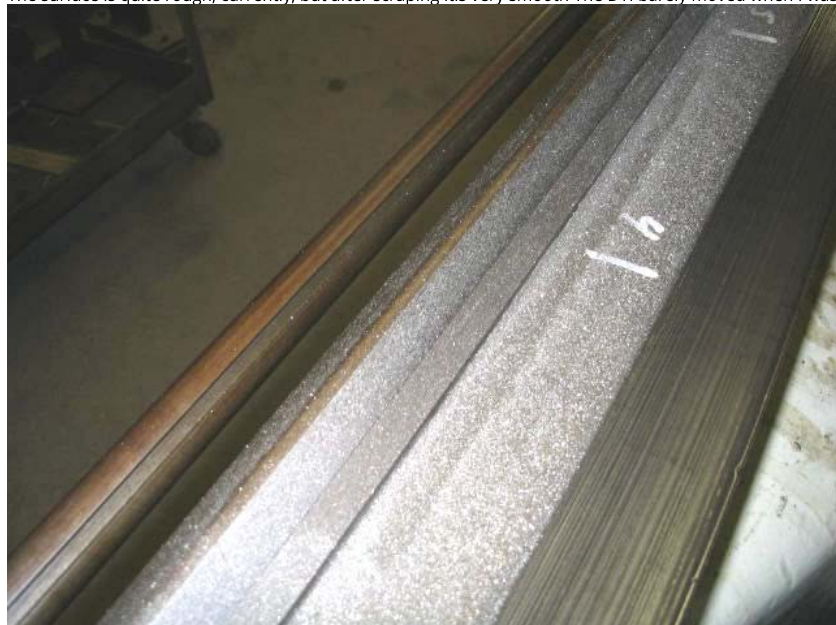
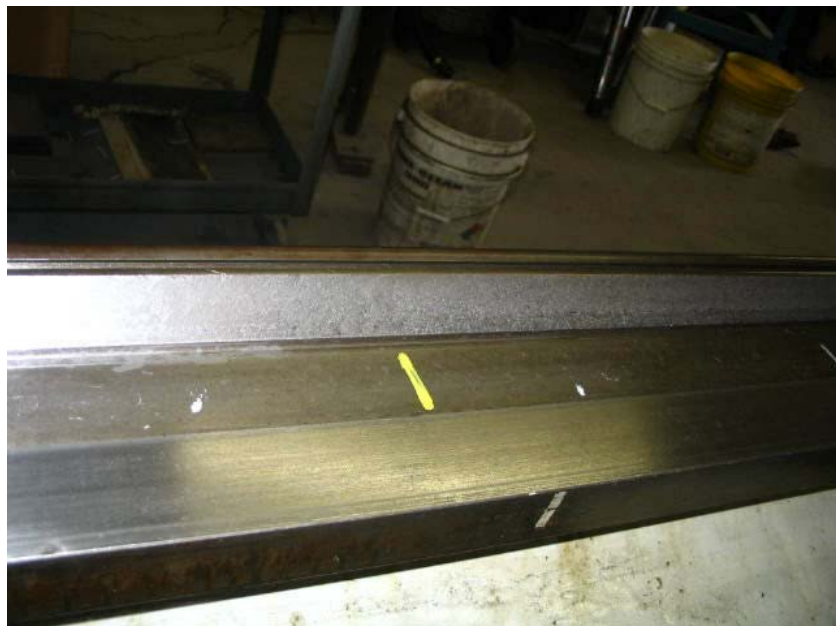
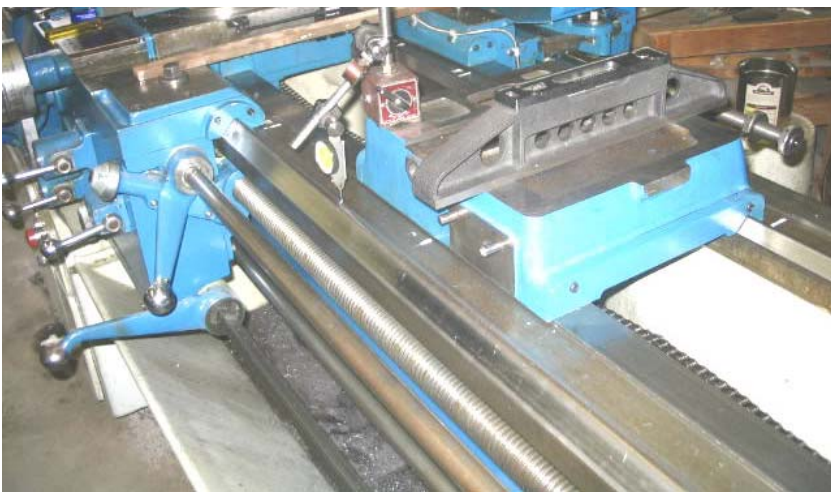
The shaped/planed section is the top half, and glitter are chips, in the first picture. The second picture, the entire face has been shaped/planed for the first 75" or so. The yellow line is a 4' marker for the straight edge.

The surface is quite rough, currently, but after scraping it is very smooth. The DTL barely moved when I was checking in the third picture.

I was able to get the first 75" or so of the bed planed/shaped using the sled. That section was then scraped for flatness and straightness, which worked out quite well. The sled was removed, the carriage moved to the TS end and the sled remounted, less the gib rollers, and I attempted to repeat the process with an extended tool holder, but was unable to get the cutter to cut, it just rubbed. The ceramic insert showed no signs of chipping or cratering. I worked on this problem for several hours, but was unable to find a cause or cure. Deflection was checked in more ways than one, nada nothing. I decided that I could scrape the remainder faster than screwing around with the sled. There are approx 37" that remain to scraped, but in reality it is approx 18" or so. This is the area that has the majority of the wear. The only hard area to scrape is the 5" or so beside the headstock, and I may have to resort to unconventional means to get the excess off. The last 3" or so, the carriage will never see, but the first 2" it is quite possible.

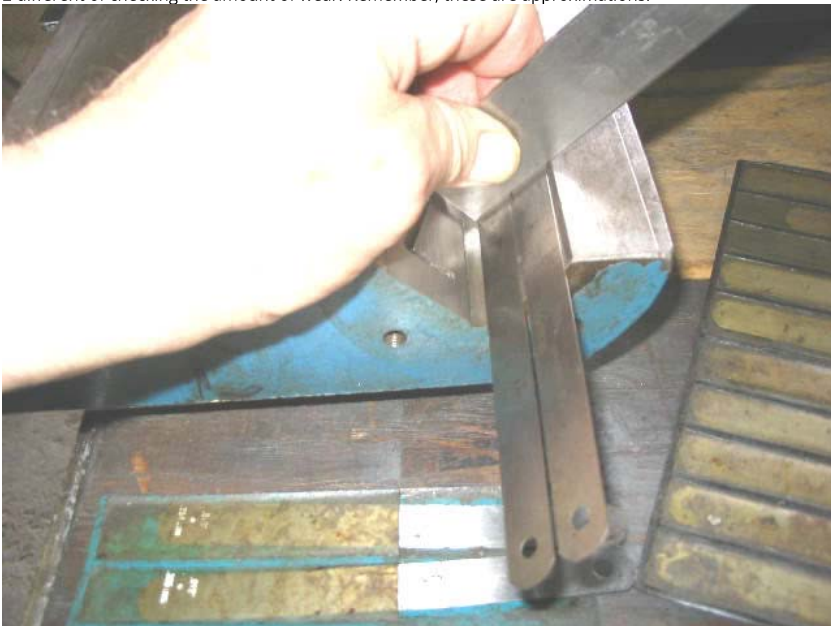
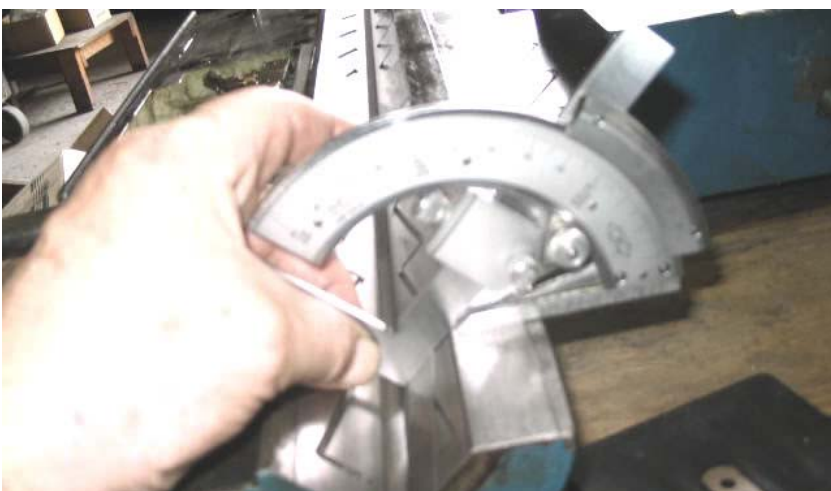
Sketch #1 is the carriage's V slide's relationship the V way of the bed after the inside was scraped. There is approx a .006" gap at the top of the inside face, which I think goes a long way to explaining the difficulty of moving the carriage.
Sketch #2 is the wear in the V slide, approx .012" on the inside face and approx .008-.010" on the outside face.

2 different of checking the amount of wear. Remember, these are approximations.

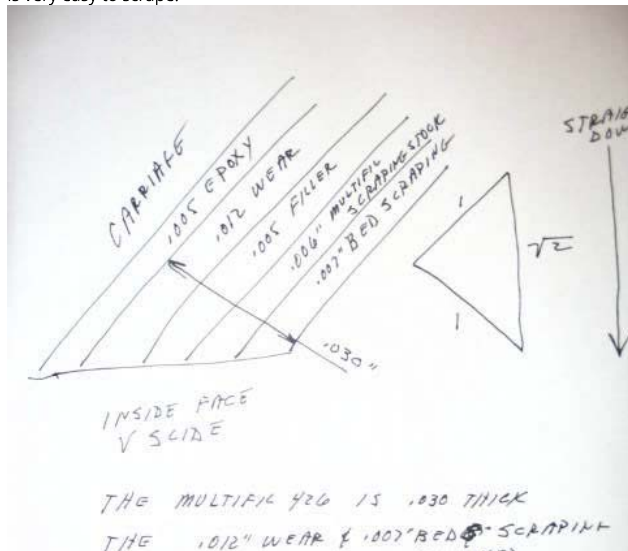
Here is the sketch for the inside face of the V slide. A sketch for the outside face would look the same, but with some changes there is no bed scraping, and the amount of wear in the face is different. One term may be a bit confusing, "filler". You can call it gap filler, but it is Multifil 426, and it's there to account for the .030" thickness of the material. I could eliminate it, but that's an extra .005" to scrape off. If you're wondering about the amount of scraping stock, it's there because it is very hard to get all the bumps out in the application, and I need some of the scraping stock to align the cross slide ways. This stuff is not CI, it is Teflon impregnated with bronze and etched on one side for adhesive, and it is very easy to scrape.

1.114
1.010" WHICH
HAS ALREADY BEEN REMOVED
THE ONLY NUMBERS THAT NEED ACCOUNTING
FOR ARE THE EPOXY & FILLER
FOR A TOTAL .010" MATERIAL REMOVAL
OR .01414" STRAIGHT DOWN

Did a little math today to figure how much to remove from each face before epoxing the Multifil. I'll clean up the sketch and post a picture tomorrow, in order to lessen the confusion of the next paragraph.
The Multifil is .030" thick, I'm allowing .005" for the epoxy, and .006" for scraping stock. For the inside face: .006" stock + .012" wear in face + .007" for amount scraped off bed + .005 filler= .030" Multifil thickness. .005" epoxy + .005" filler= .010" to machine off the face, or .01414" straight down (this is the number I really need due to the way I'm setting it up on the mill). For the outside face I need to remove .021" from the face, or .029694 straight down, using .008" wear factor for the slide face. I'm not figuring any wear factor for the outside face of the V way. For the rear flat slide, I'm not figuring any wear factor on the slide or the way, so a .030" material removal will used.

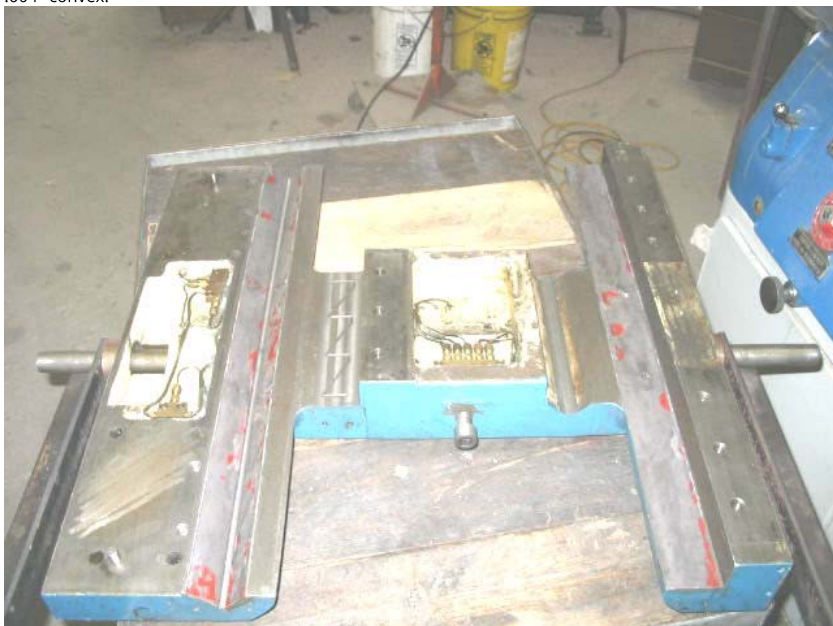
The 3rd spotting cycle. The red medium is being used because it's easier to see on the black Multifil as the scraping progresses. After this was scraped, I did an alignment test with the cross slide, and it's time to start some selective scraping in the V slide. As it is now the CS is about .004" convex.

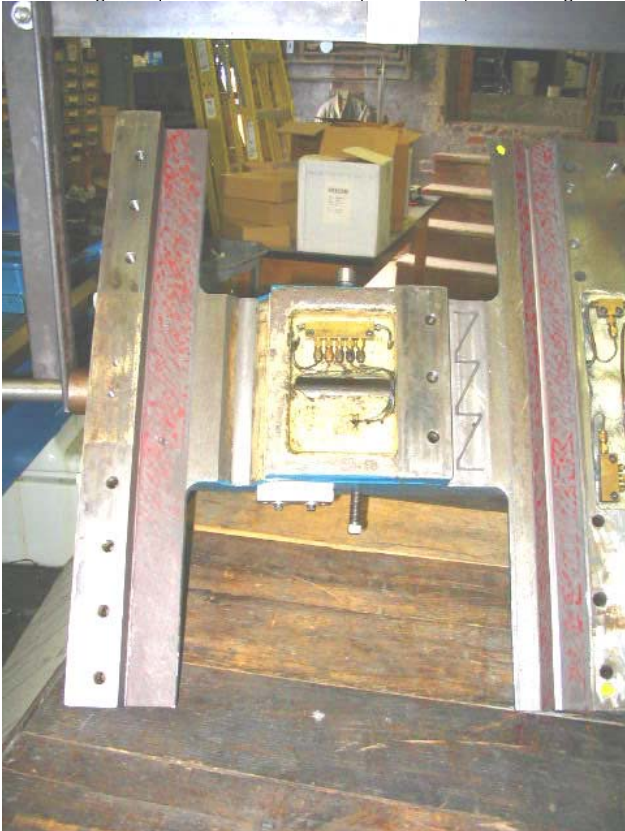
The picture below is about the 20th spotting, as you can see a lot of progress has been made. I now have a 0-0 reading on the cross slide, actually it's been fluctuating between 0-0 and .0003" concave for the past 8 or so cycles. The balance of the cycles have been to improve the bearing area, and I'm trying to the drop front approx .002" for cross slide parallelism to the bed. I did a couple more cycles after the picture and the bearing area has been further improved, especially on the flat slide. Also consider that the total bearing area of the slides has been increased approx 20%, due to the continuous surfaces of the slides. Originally, there was a gap, in the surfaces, under the bridge. If you look at the V slide, there are 2 yellow dots. These are reference markers I used to tell me which end of that surface got scraped to turn the carriage for the cross slide alignment. It gets very confusing when the carriage gets turned over, remembering which end to scrape. Each of those faces got scraped from the dot to a couple of inches past the bridge.

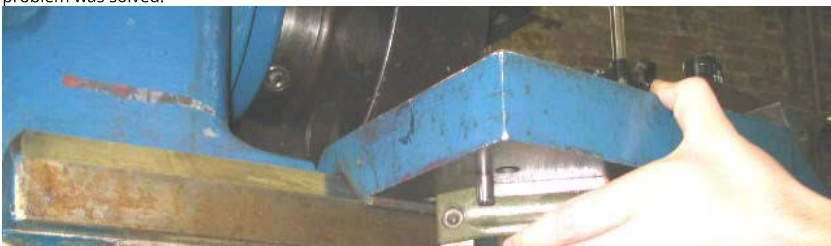
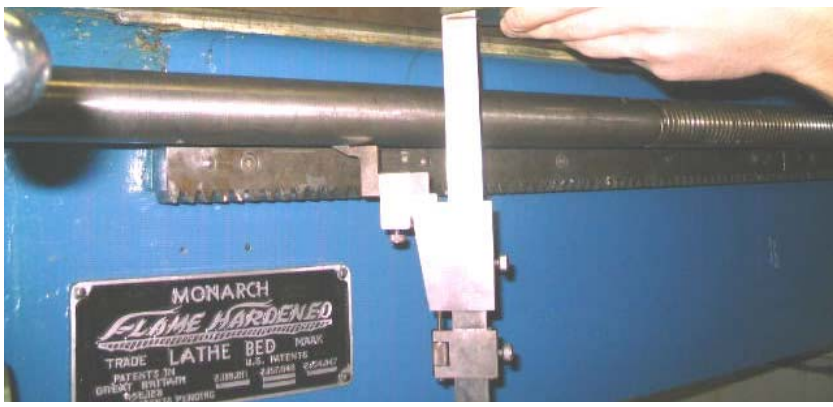
3 more scraping cycles on the V slide resulted in the lowering of the front approx .0015". I ran the accuracy checks on cross slide alignment, 0-0, transverse level .0005"/12", high in front, L-R level, low L approx .001"/12" and carriage/leadscrew relationship is 3.250" +/- .002", this is the dimension I was looking for earlier. I can try to improve the L-R level readings, but everything else is good to go. The next thing I have to do, is cut the oil grooves in the slide faces, then this carriage is going back together, and I take some test cuts. The carriage/leadscrew check. This is the method Russ and I were discussing earlier. I found out the problem I was having earlier was caused by the gear key riding up the keyway slot, not allowing the leadscrew to seat properly in the angular contact bearings, removed the key and the problem was solved.

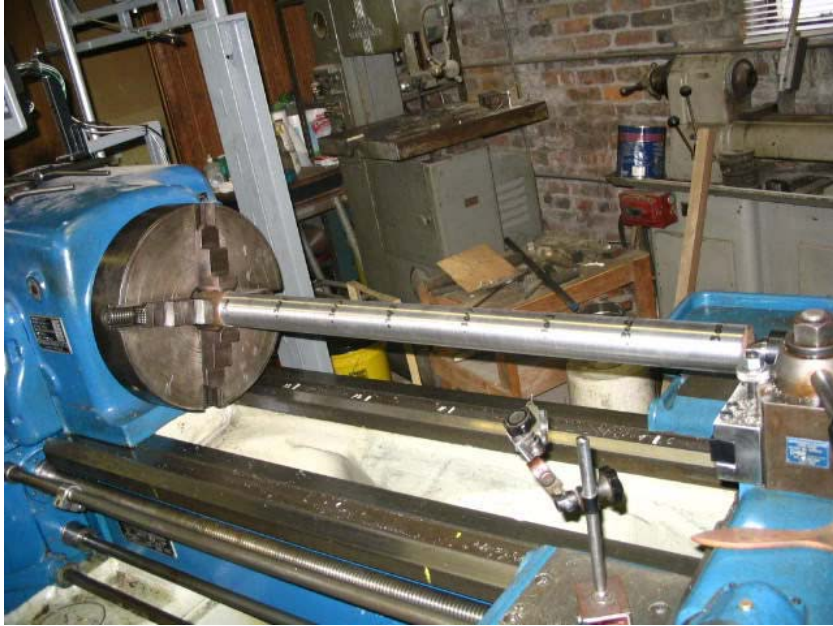
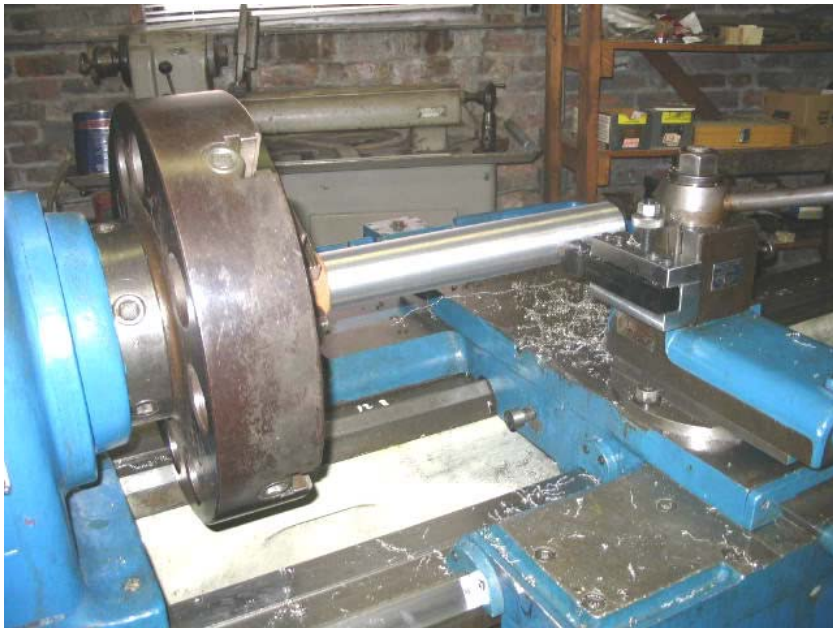
35" and 14" test bar cuts after the reassembly. Unfortunately, I have lost my notes on the recorded dimensions, but for the 35" bar there was .0014" differential between the high and low. IIRC, the biggest difference was on the TS end, with the middle being relatively constant, and a minor variation on the HS end. I could have worked with these results, but I decided to do a modified "2 collars test" on the 14" bar. A .004" difference, small at the HS, convinced me otherwise.

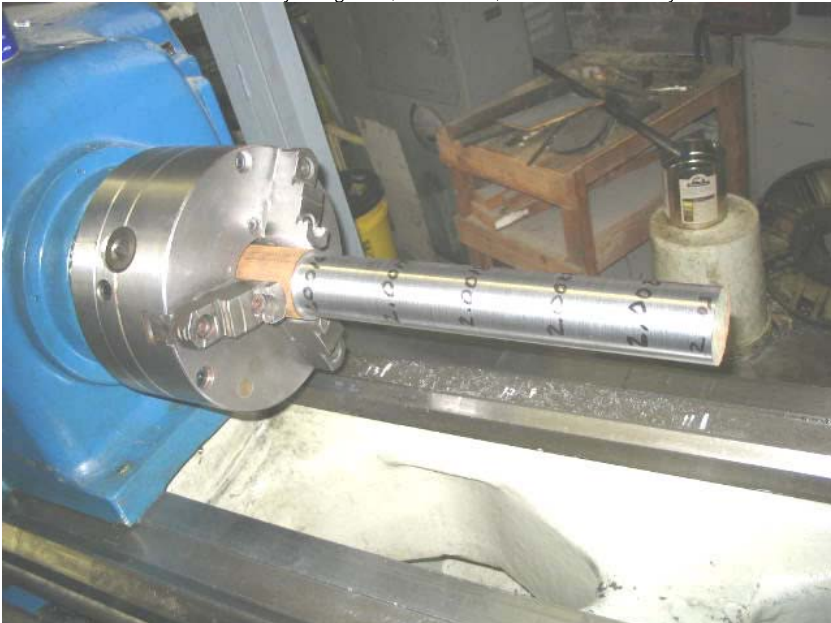
The final 14" test bar results. The results from yesterday afternoon are; HS 2.2016", 4"- 2.2015", 7"- 2.2018", 10"- 2.2022, 12"- 2.2024", 14"- 2.203". Remeasured this AM the only changes are; 10"- 2.2018", and 14"- 2.2028". Maybe there is a reason the 2 collars test is only 12" long.

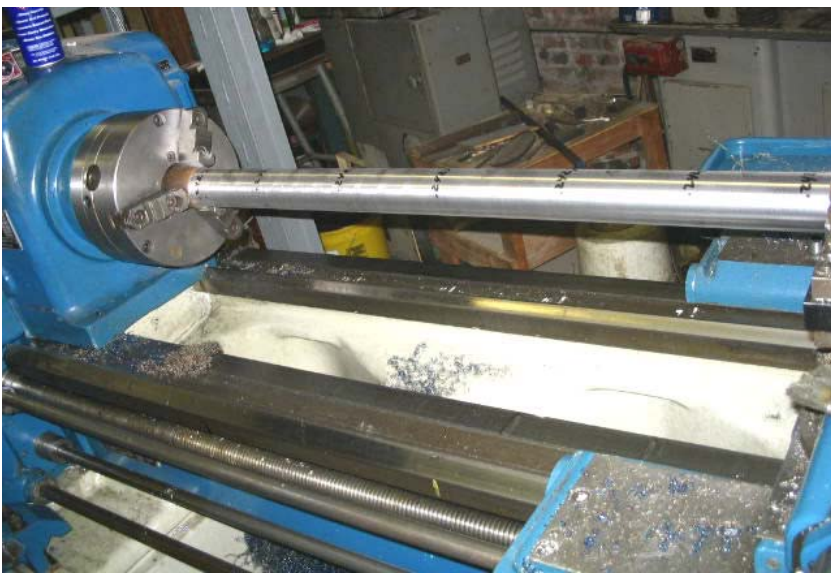
The final 35" test bar results. The results from late yesterday afternoon are; HS 2.2427", 6"- 2.2425", 12"- 2.2423", 18"- 2.2427", 24"- 2.2427", 30"- 2.2426", 35"- 2.2427". Remeasured this AM; HS 2.2423", 6"- 2.2423", 12"- 2.2423", 18"- 2.2422", 24"- 2.2424", 30"- 2.2426", 35"- 2.2425".

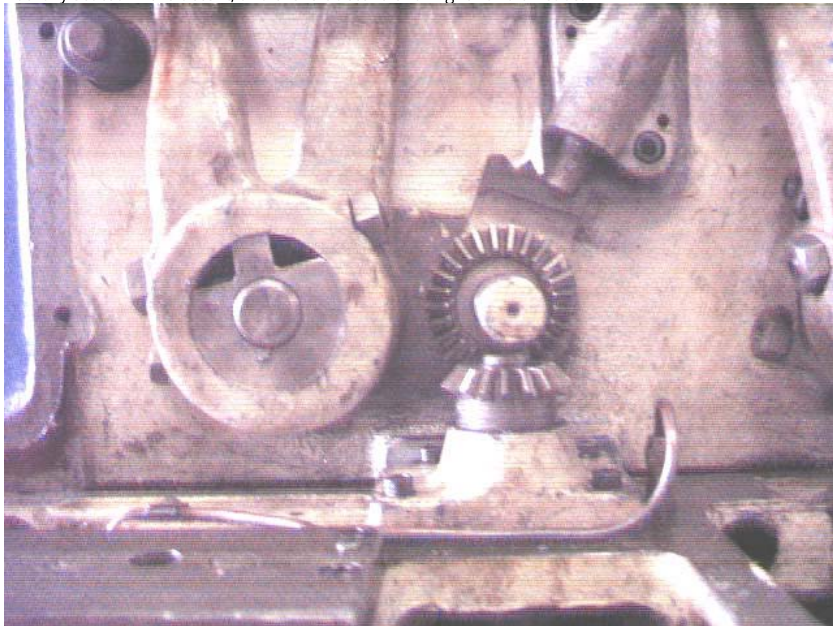
The bevel gear and detent for the leadscrew reverse. The center detent is neutral, the right detent is for left hand threads, and the plunger is not fully seated in the detent, and the left detent is for right hand threads.

Finally got back to the lathe yesterday afternoon, and figured out how to get the segment out without too much trouble. Take the snap ring off the top of the shaft over the small bevel gear, and get the taper pin out of the bevel gear, which is a lot easier said than done, and co-erse the shaft straight down into the gearbox, and hopefully not drop it, again a lot easier said than done. Finally teased it out. I was expecting to find a loose taper pin, pinning the segment to the shaft, but found a Woodruff ket and a set screw. There was a bit of movement, but not enough to account for what I saw earlier. Looked at the taper pin hole in the bevel gear, and it was oval, an ah-ha moment. Ream the taper pin hole in the gear and shaft to a larger size, for a properly fitted taper pin, and while I was at it, add a taper pin to the gear segment on the bottom, to really get this assembly nice and tight. Reassembled the gear segment in the gearbox, and the reverse shaft and gave it a test run. I still got the problem. I could force the gear segment a bit further, and the reverse function would work, but I'm not about to stand there with a screwdriver and the gearbox top off, while trying to run the lathe. Obviously, I'm missing something here.

Thought about for awhile, and decided to check the reverse gearing inside the headstock, to see if the shifter shoes were excessively worn. Off came the headstock cover, with the forklift's help, and all was good inside. So what could it be? I did find the limits of the segment's travel, by looking at the dog teeth engagement inside. Tried different positioning of the detent bracket, and of the circular gear rack engaging the gear segment, and several other ideas, all to no avail. The only conclusion I could come to, was that the worm was a bit too long on one end, it's travel is limited by either the dog clutch inside the headstock, or the sides of the gearbox, and I couldn't tell which one it was, as I had already reinstalled the headstock cover. I opted to shorten the worm 1/16" on each end, and hope it works. It did, I can't force the gear segment in either direction.

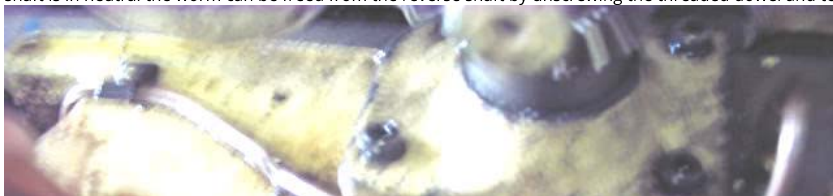
The ball driver is on the gear segment, that is compounded to the small bevel gear in the previous picture. The circular rack is pinned the reverse shaft, and on the left is the nut block, in which is the 4 start worm pinned to the shaft. In case you are wondering, when the reverse shaft is in neutral the worm can be freed from the reverse shaft by unscrewing the threaded dowel and teasing it out.

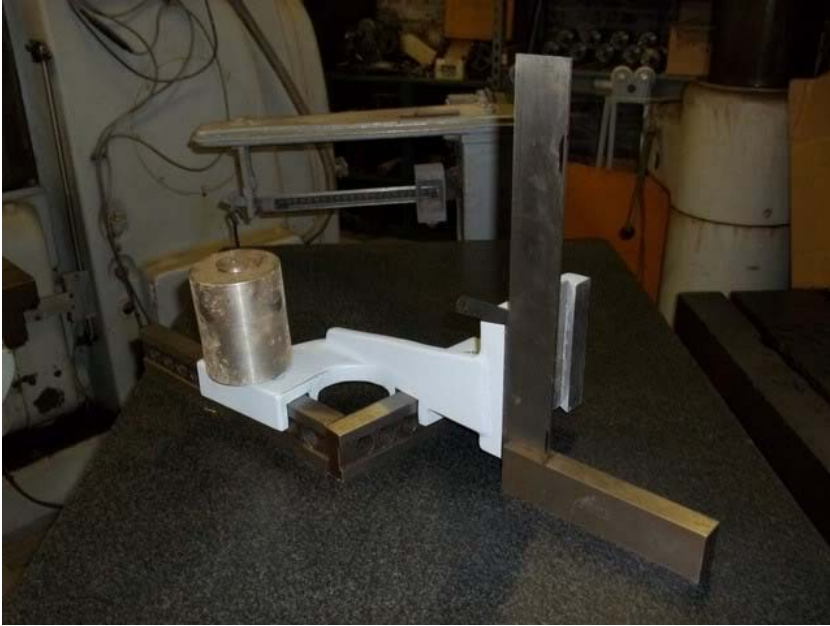
Checking for squareness of the weldment. Of course I would think of this after priming. It's hard to see, but there is a .012" feeler gauge between the square and the top.
